From: s41(1)
To: Clayton, Des
Subject: RE: Odour compliant [SEC=UNCLASSIFIED]
Date: Thursday, 11 August 2016 12:20:38 PM
Attachments: [Attached Image.msg](#)
[.msg](#)
[.msg](#)

From: [Clayton, Des](#)
To: s41(1)
Cc: s41(1)
Subject: Odour complaint Mugga lane RMC [SEC=UNCLASSIFIED]
Date: Friday, 18 November 2016 9:56:00 AM
Importance: High

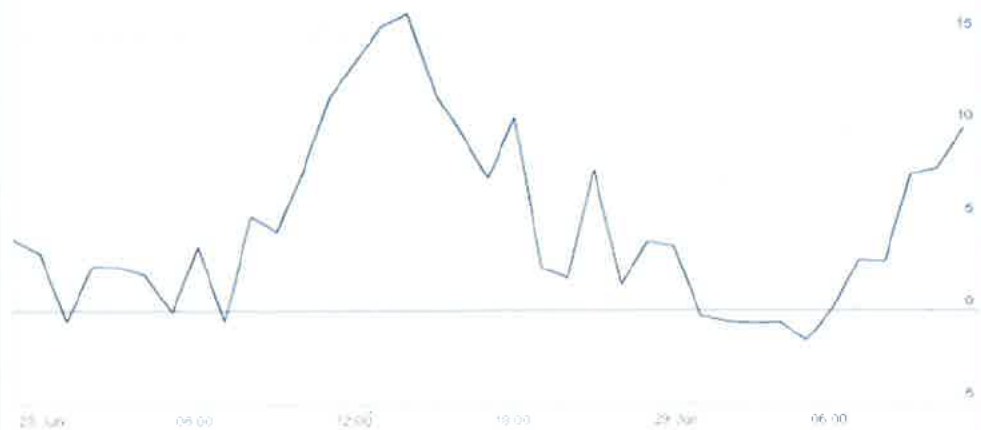
● Min: -1.61°C Max: 16.02°C

28 Jun 2016 [00:00:00] - 29 Jun 2016 [12:28:00]

● Meteorological - Air Temperature (°C) 5min AVG

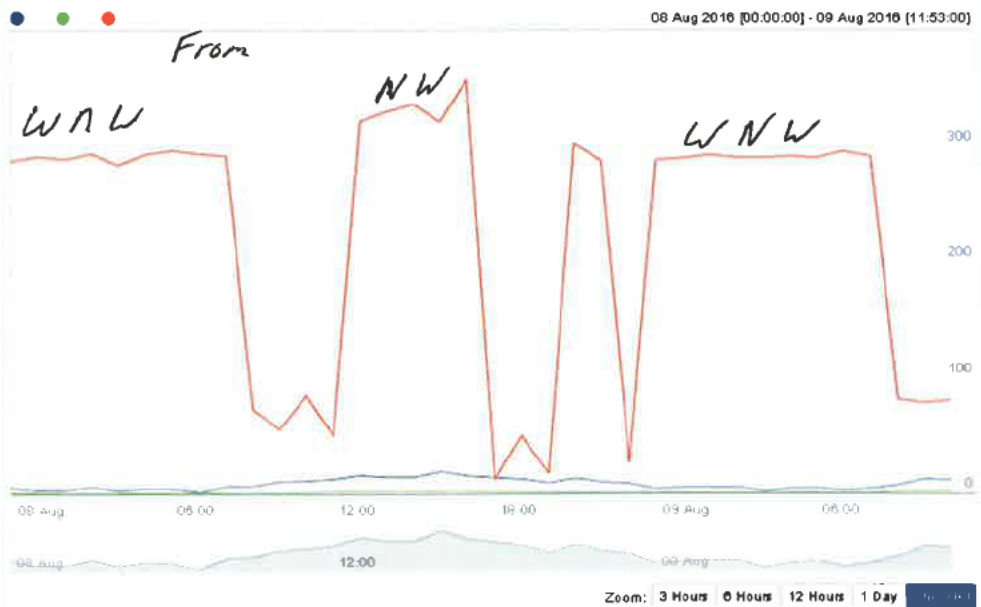
HISTORIC TREND

- a) Meteorological conditions at the site for the past 48 hours; I have attached the information from the on site weather station with the winds manly from the WNW
- b) Time and date stamped photographs of the active tip face including photographs showing intermediate and daily cover; I don't have a good photo of the tip face on the day there are 3 photos show parts of it and the cover marital but it was down in the lower western side of AC that we were looking down on yesterday
- c) Details of any projects currently being undertaken by third parties that may impact on the generation of odour; Nil
- d) Details of any measures taken or proposed to be taken to deal with odour generation ; Discharging of Leachate dam form 82%
- e) The current level of the leachate dam. 28%

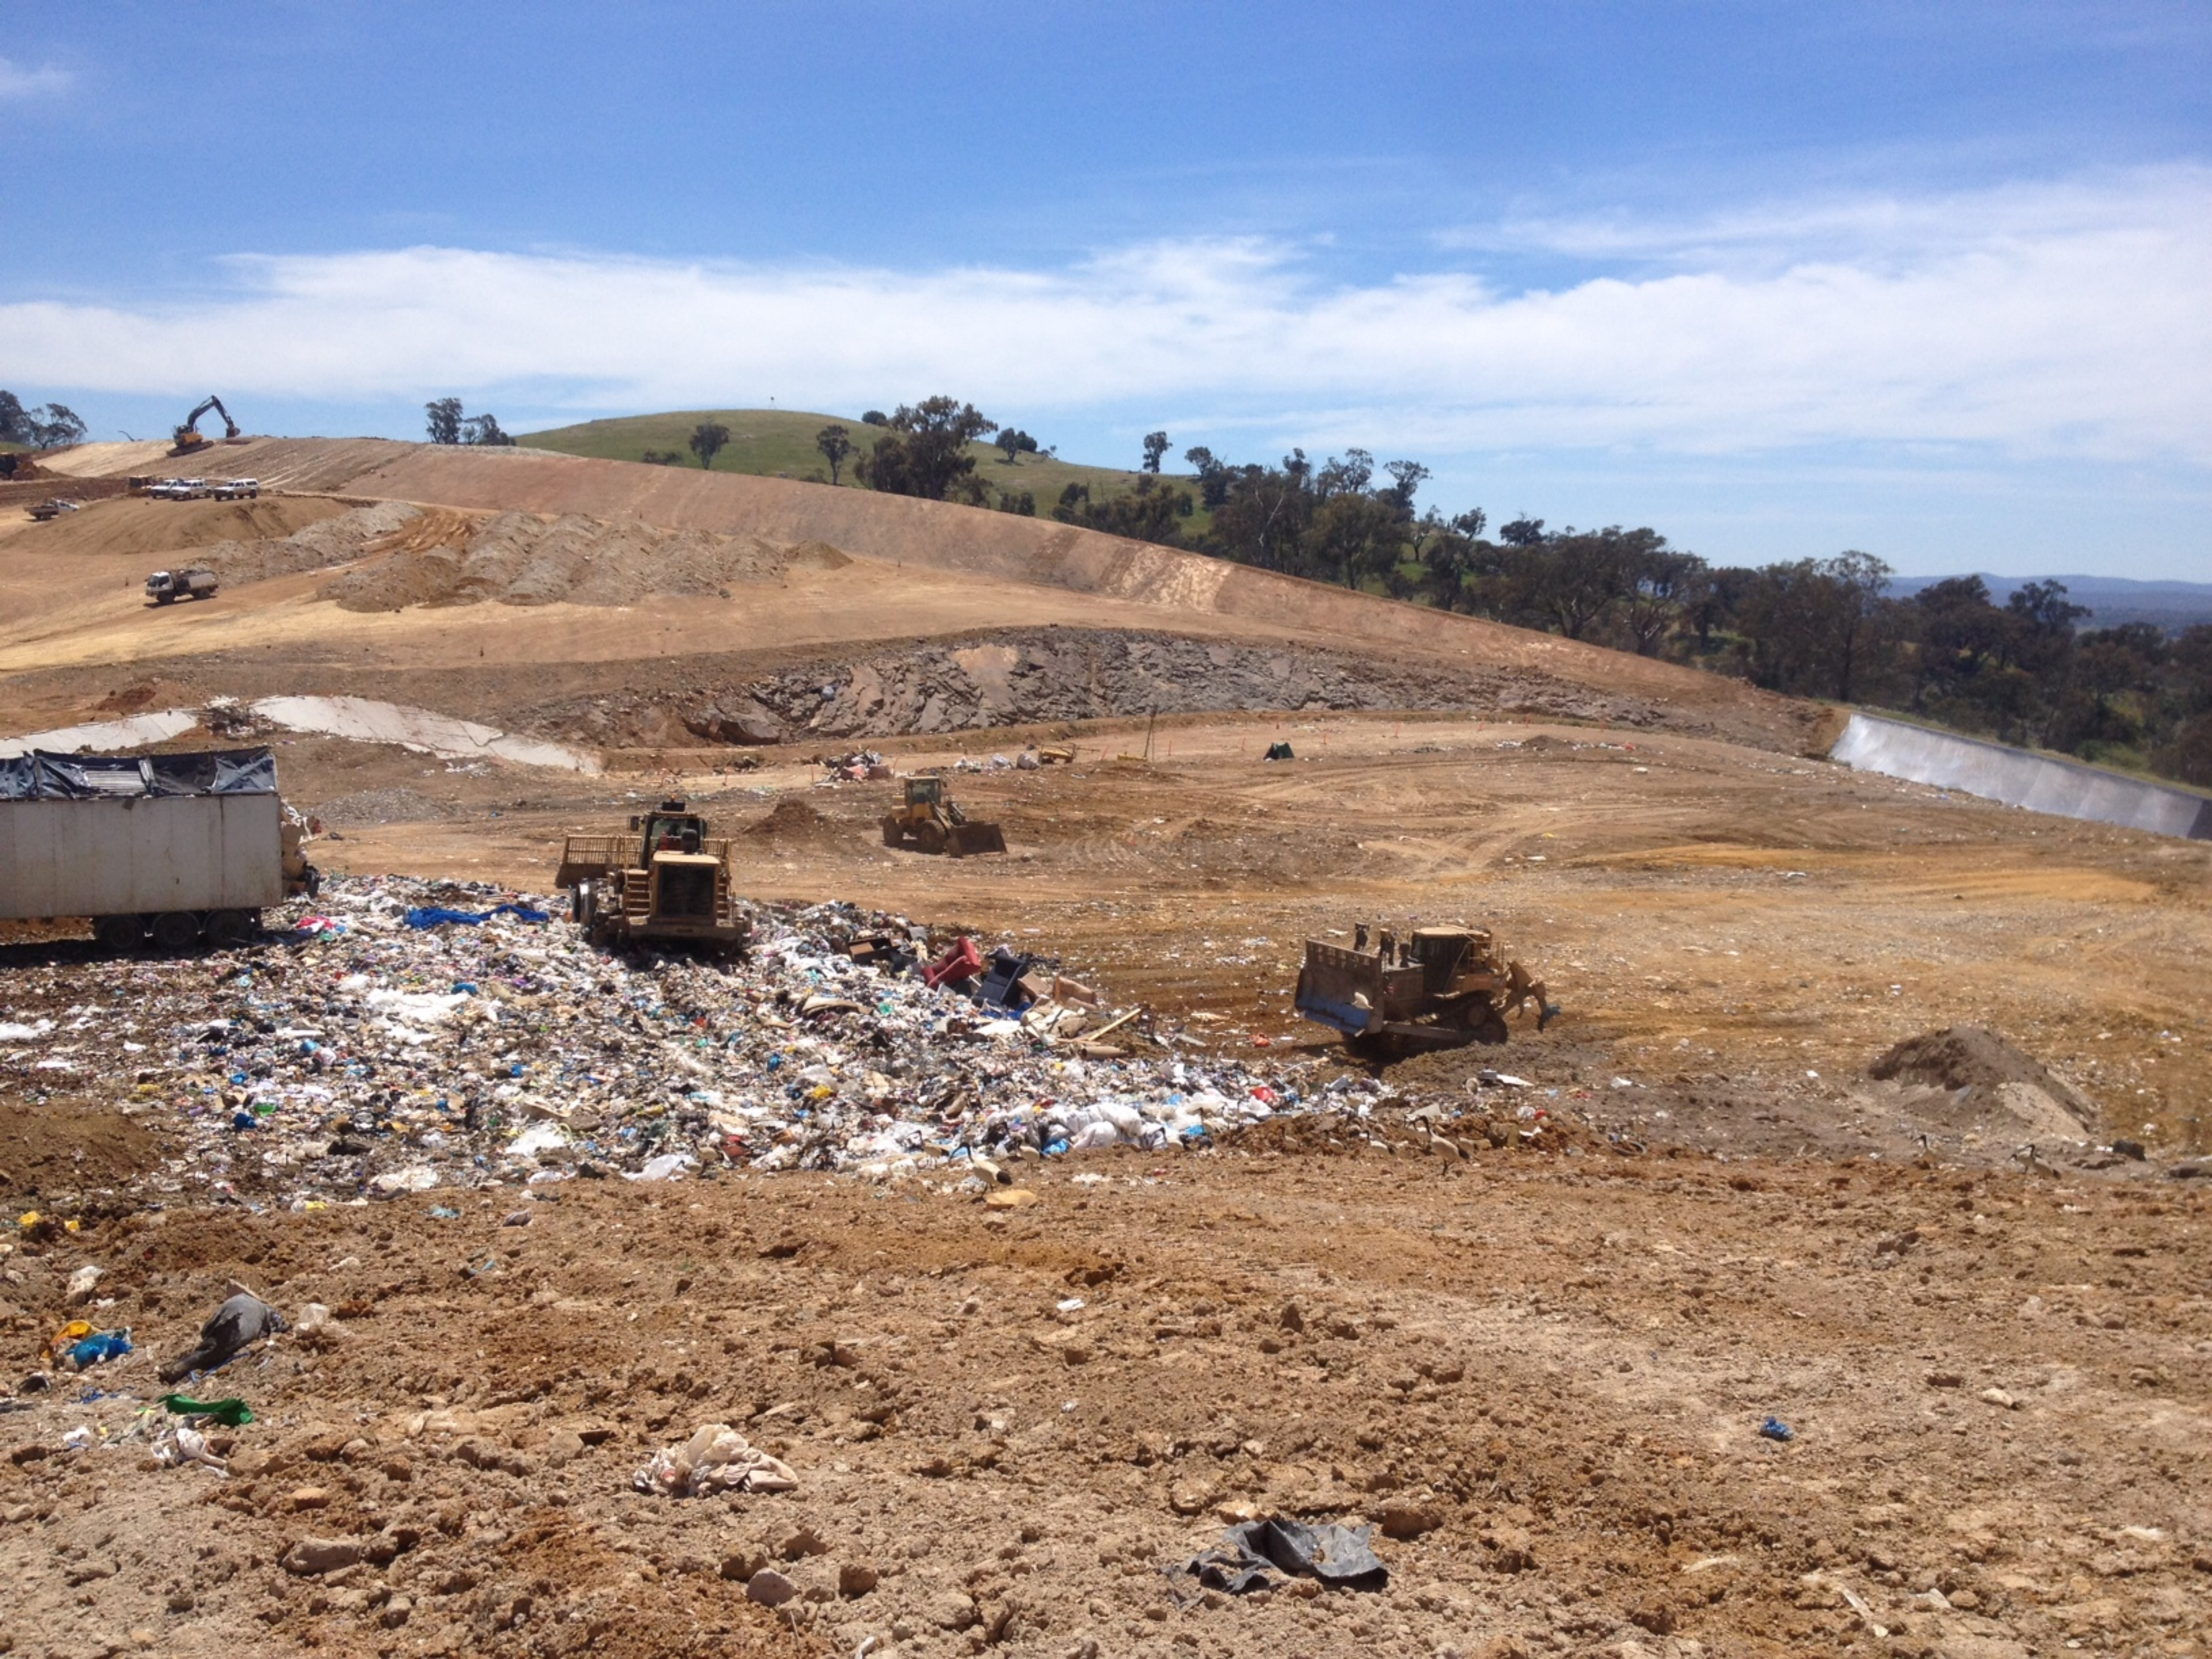
- a) Meteorological conditions at the site for the past 48 hours; **Thursday 17/11 25degrees with 18 kmh winds. Friday 18/11 low 10 degrees now 23 degrees with NNE wind at 11kmh**
- b) Time and date stamped photographs of the active tip face including photographs showing intermediate and daily cover; **Attached**
- c) Details of any projects currently being undertaken by third parties that may impact on the generation of odour; **There is no works on site at the Mugga lane RMC that would generate odour that are in Remondis control**
- d) Details of any measures taken or proposed to be taken to deal with odour generation; **Normal operation procedure followed Eg : 30 x 30 tipface cover up to 80% over night with soil**
- e) The current level of the leachate dam. **24% full.**

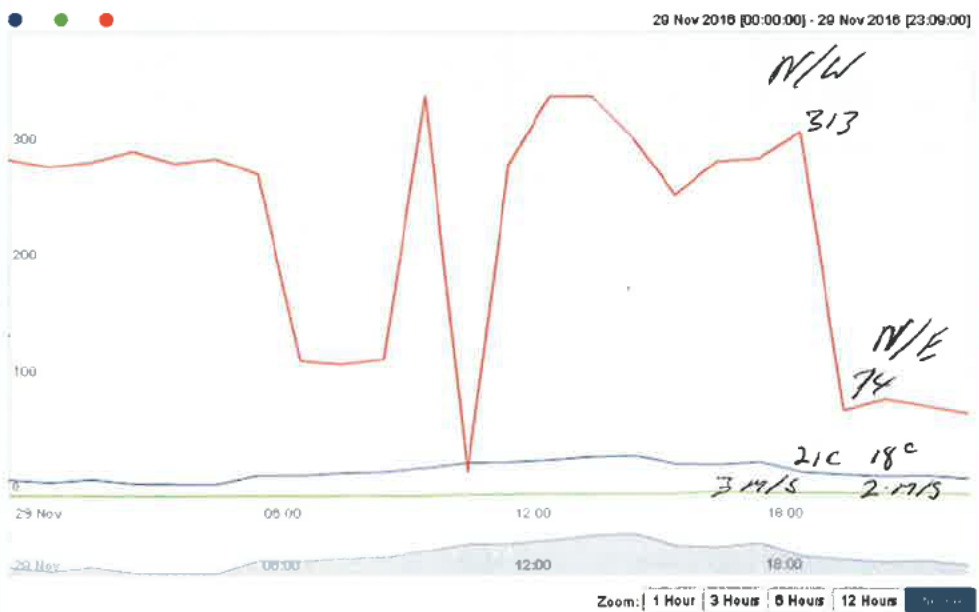
HISTORIC TREND

The weather condition on the 29/11/16 have been attached that have been taken from the onsite weather station,
The winds were N/W to N/E around 10kmh at 6pm.
The tipface was around 30m wide by 15m long and covered by 6pm 29/11/16
A photo has been attached showing the tipface and the cover martial being placed behind the dozer.

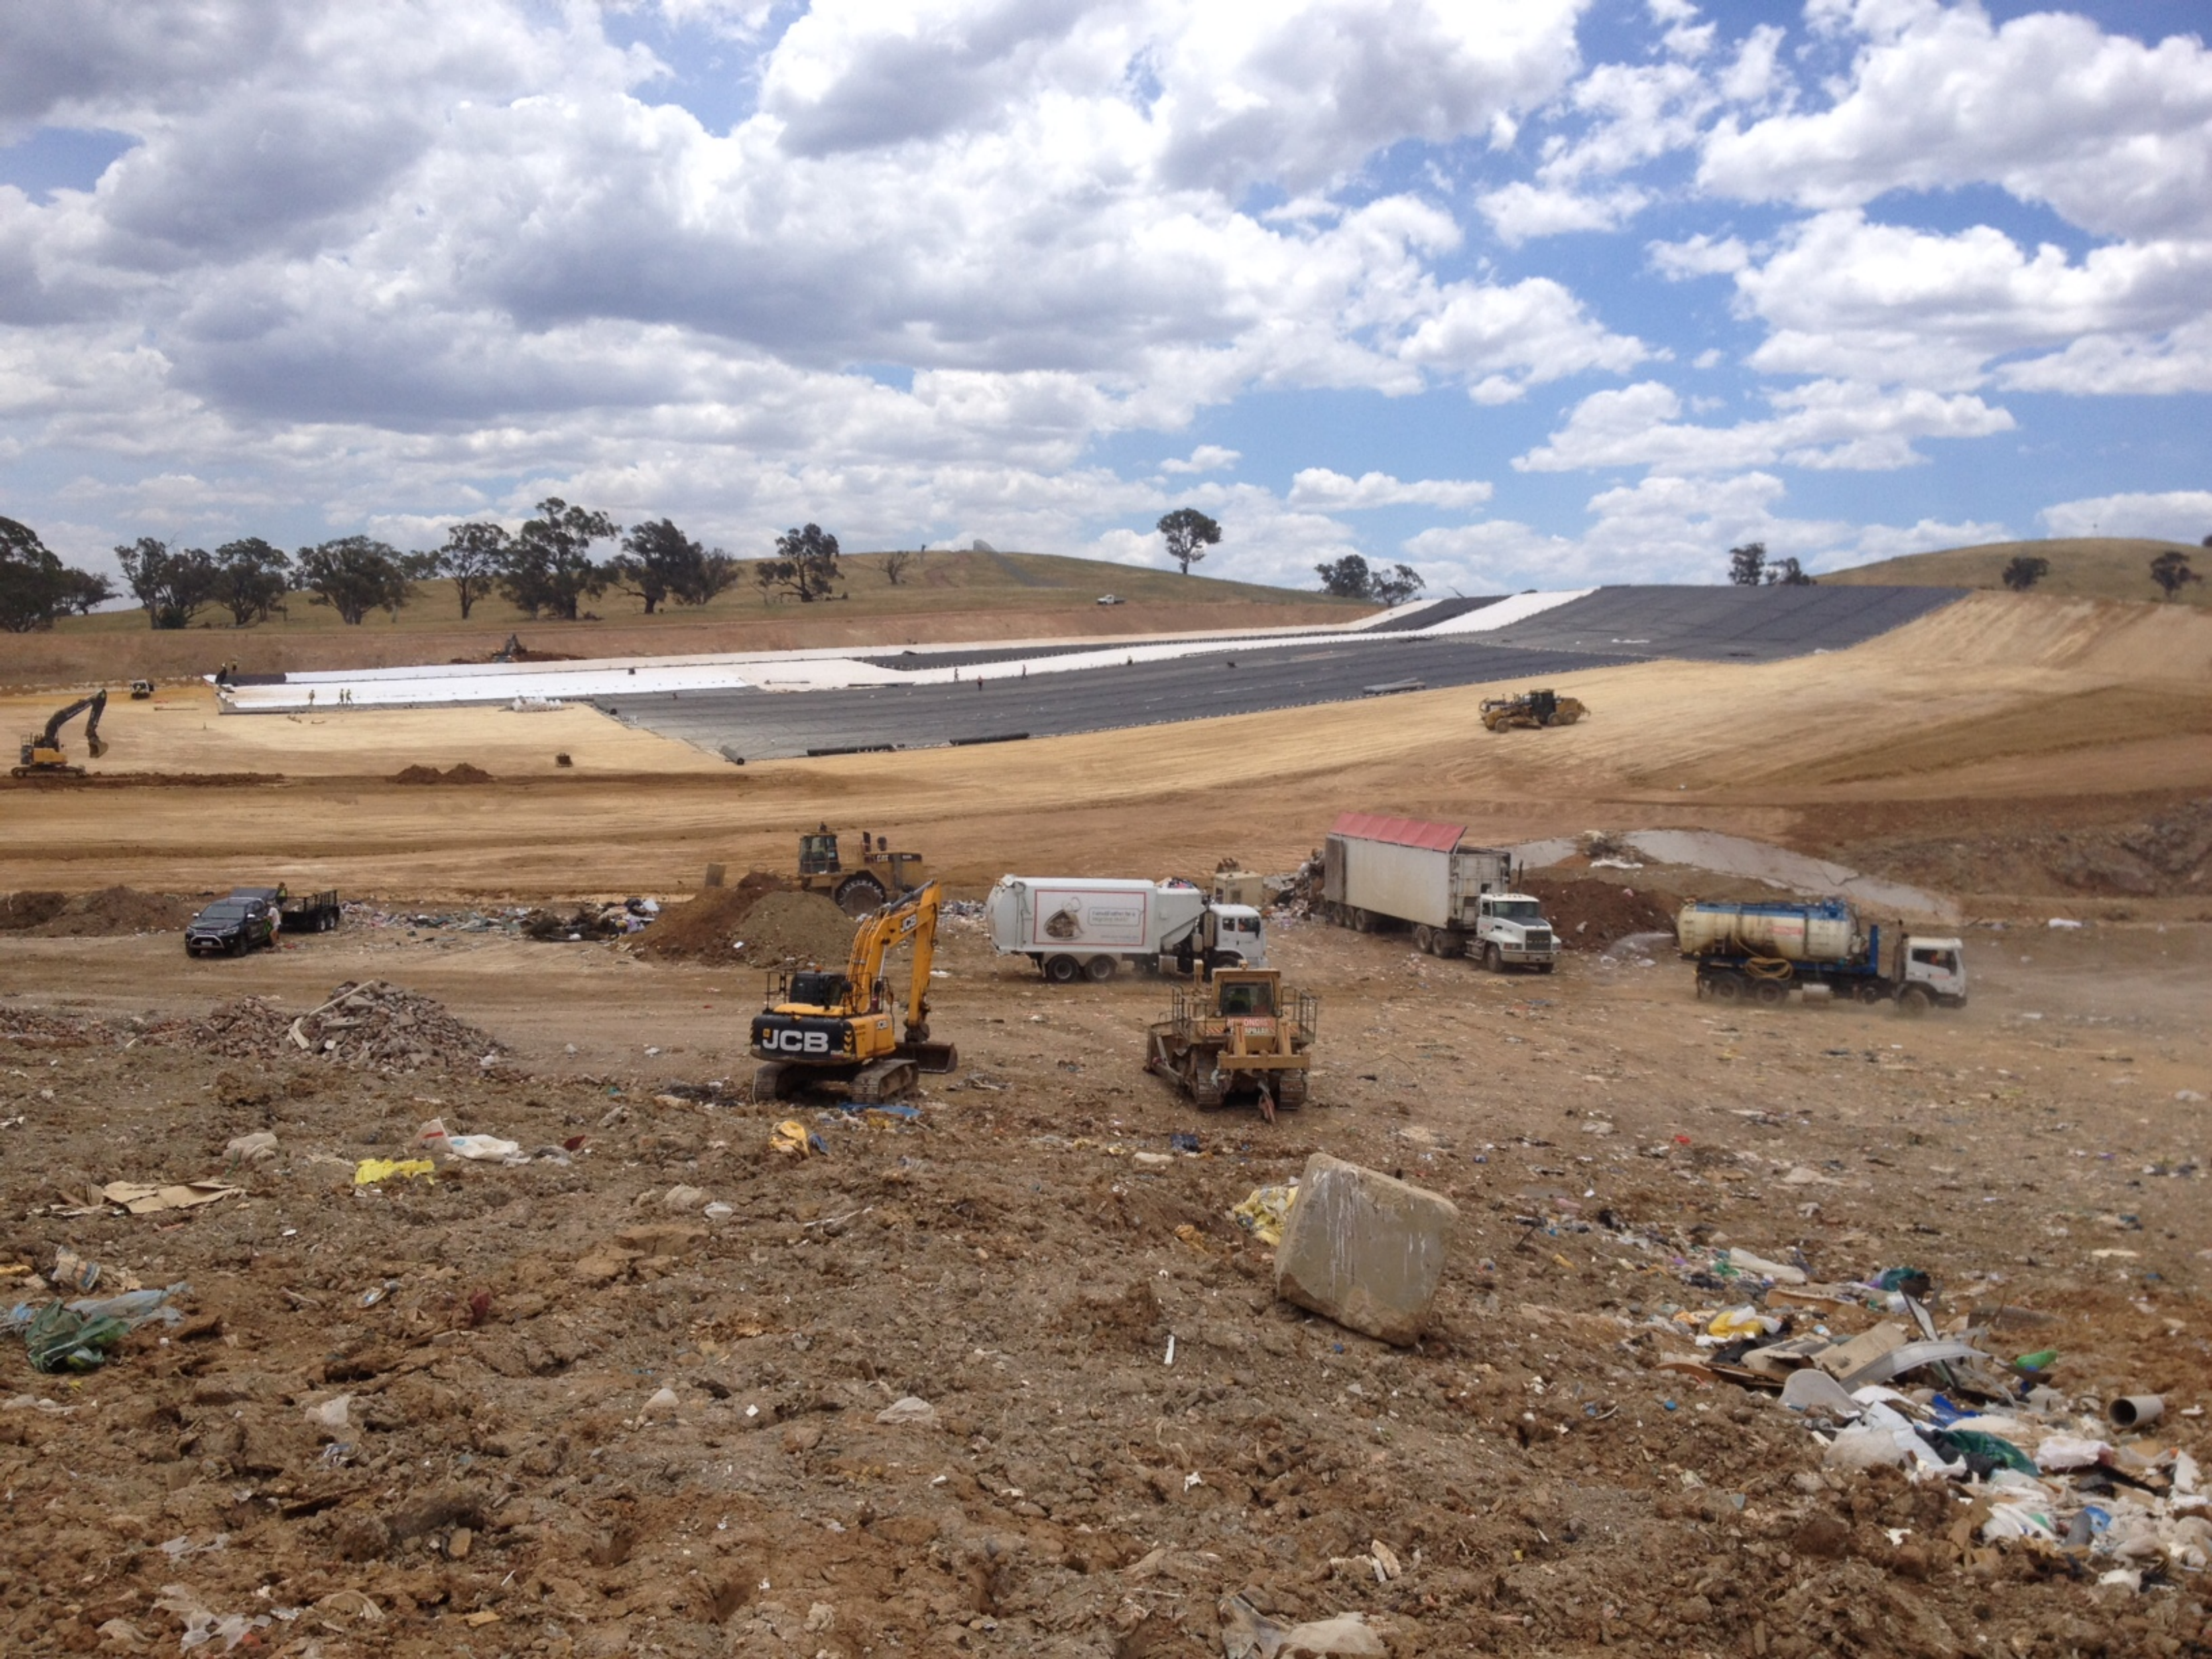
- a) Meteorological conditions at the site at the time; 17 degrees c winds from the N/W under 10 kmh
- b) Time and date stamped photographs of the active tip face including photographs showing intermediate and daily cover; Attached Tipface 40 meters wide by 10 meters long
- c) Details of any projects currently being undertaken by third parties that may impact on the generation of odour; Nil to report
- d) Details of any measures taken or proposed to be taken to deal with odour generation; N/R
- e) The current level of the leachate dam. 23% full

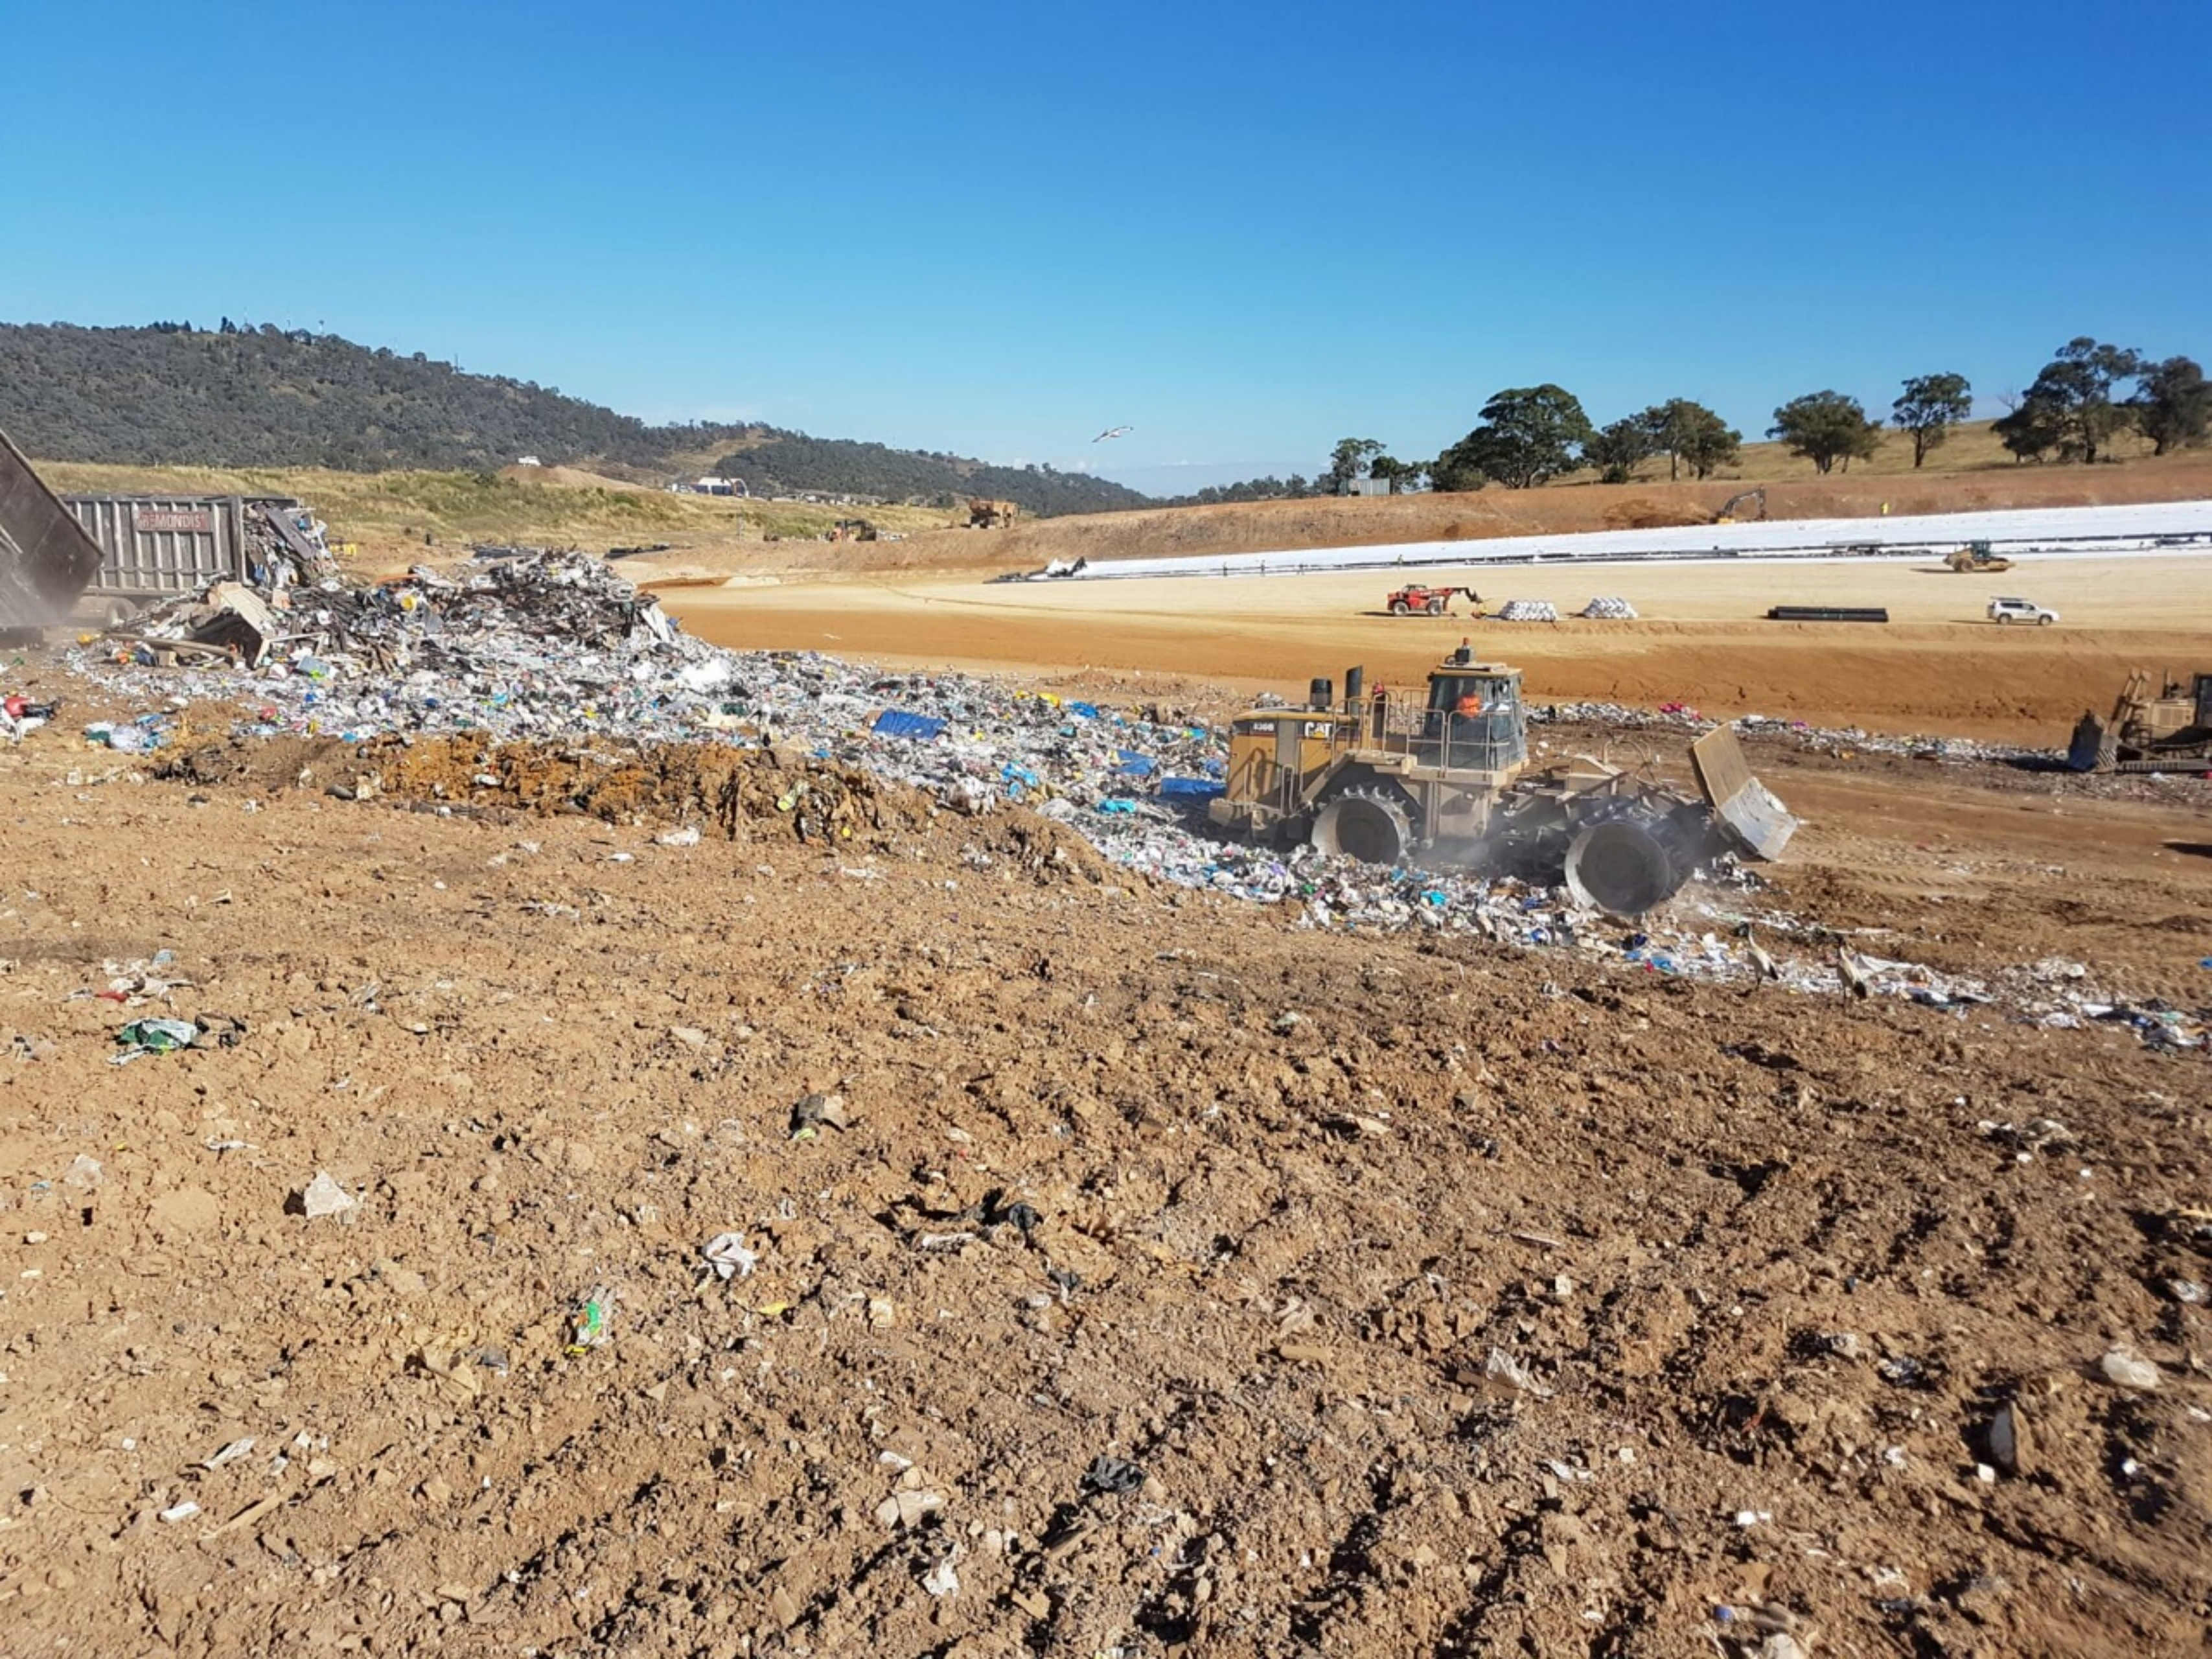
- a) Meteorological conditions at the site at the time; **The temperature was around 26 degrees at 10 am with the wind coming from the north west around 10 kmh (Heading toward south Hume)**
- b) Time and date stamped photographs of the active tip face including photographs showing intermediate and daily cover; **Attached current tipface . I cannot download yesterday photo off the camera but show you when you come to site next**
- c) Details of any projects currently being undertaken by third parties that may impact on the generation of odour; **Nil till report**
- d) Details of any measures taken or proposed to be taken to deal with odour generation; **Covering waste daily and keeping tip face under 900m3**
- e) The current level of the leachate dam. **25% full**
- f)

We had odour from the tipface when we ripped out around 7:30 am but nil around the Remondis controlled parts of site after that that I notice beside the dead animal smell noted in the daily diary report .

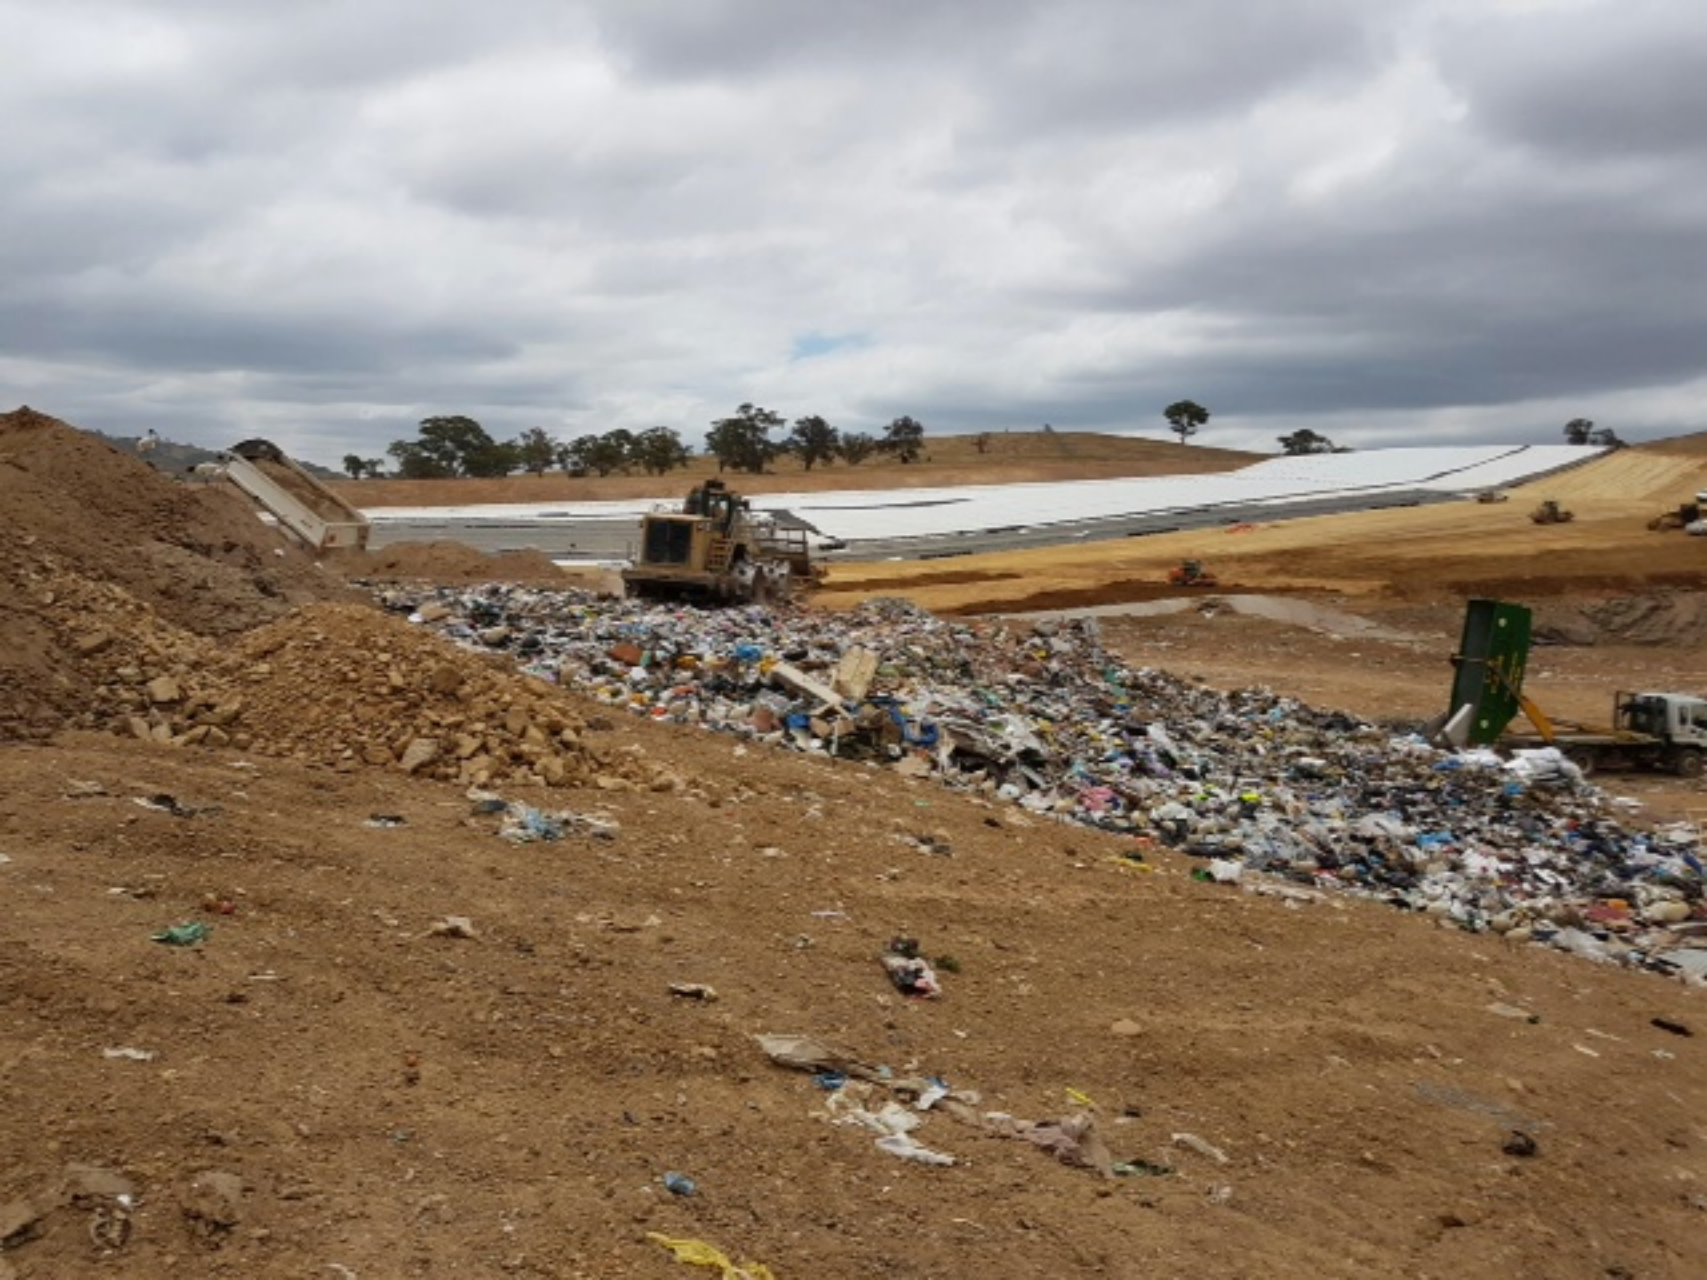
- a) Meteorological conditions at the site at the time; 19 degrees with 5kmh wind N/E
- b) Time and date stamped photographs of the active tip face including photographs showing intermediate and daily cover; see attached
- c) Details of any projects currently being undertaken by third parties that may impact on the generation of odour; Nil on site
- d) Details of any measures taken or proposed to be taken to deal with odour generation; Tipface kept less than 30 x 30m in size and covered with soil at the end of each shift.
- e) The current level of the leachate dam. 15% full

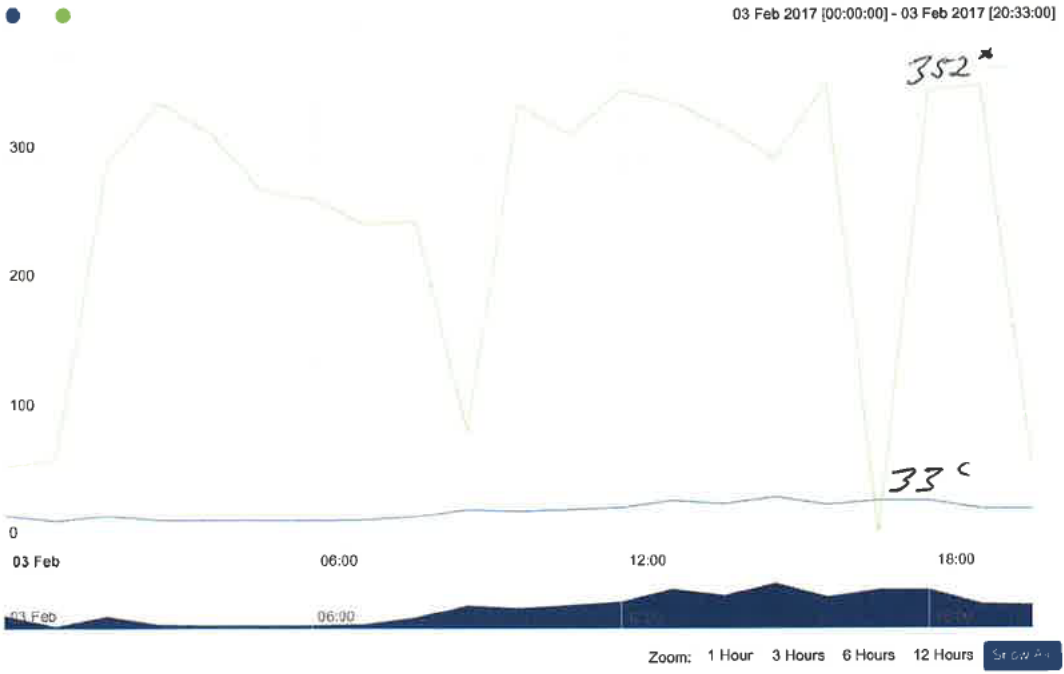
- a) Meteorological conditions at the site at the time; 33 degrees with wind to the North
- b) Time and date stamped photographs of the active tip face including photographs showing intermediate and daily cover; Sorry there is no photo of the tip face at this time due to the camera being on charge I can send though a photo of the previses day if required
- c) Details of any projects currently being undertaken by third parties that may impact on the generation of odour; Nil activities to report
- d) Details of any measures taken or proposed to be taken to deal with odour generation; Tip face no bigger then 30meters by 30 meters and covered with soil at the end of shift and would have been nearly covered at this time
- e) The current level of the leachate dam. The leachate dam is down to 10 %

03 Feb 2017 [00:00:00] - 03 Feb 2017 [20:33:00]

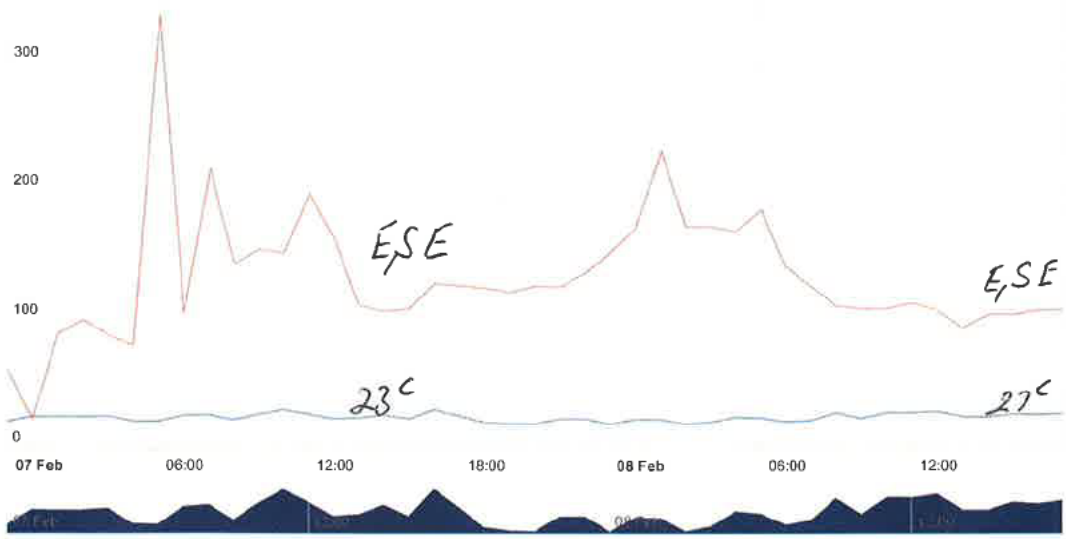
- a) Meteorological conditions at the site at the time; 7th E,SE and 23degrees 8th E,SE and 27 degrees
- b) Time and date stamped photographs of the active tip face including photographs showing intermediate and daily cover; See attached
- c) Details of any projects currently being undertaken by third parties that may impact on the generation of odour; D &H are working on the edge of the cell exposing the liner for the liner connection but are cover covering any waste as they go.
- d) Details of any measures taken or proposed to be taken to deal with odour generation; 30x 30 tipface covered with soil at the end of each shift
- e) The current level of the leachate dam. 9% full
- f)

07 Feb 2017 [00:00:00] - 08 Feb 2017 [18:00:00]

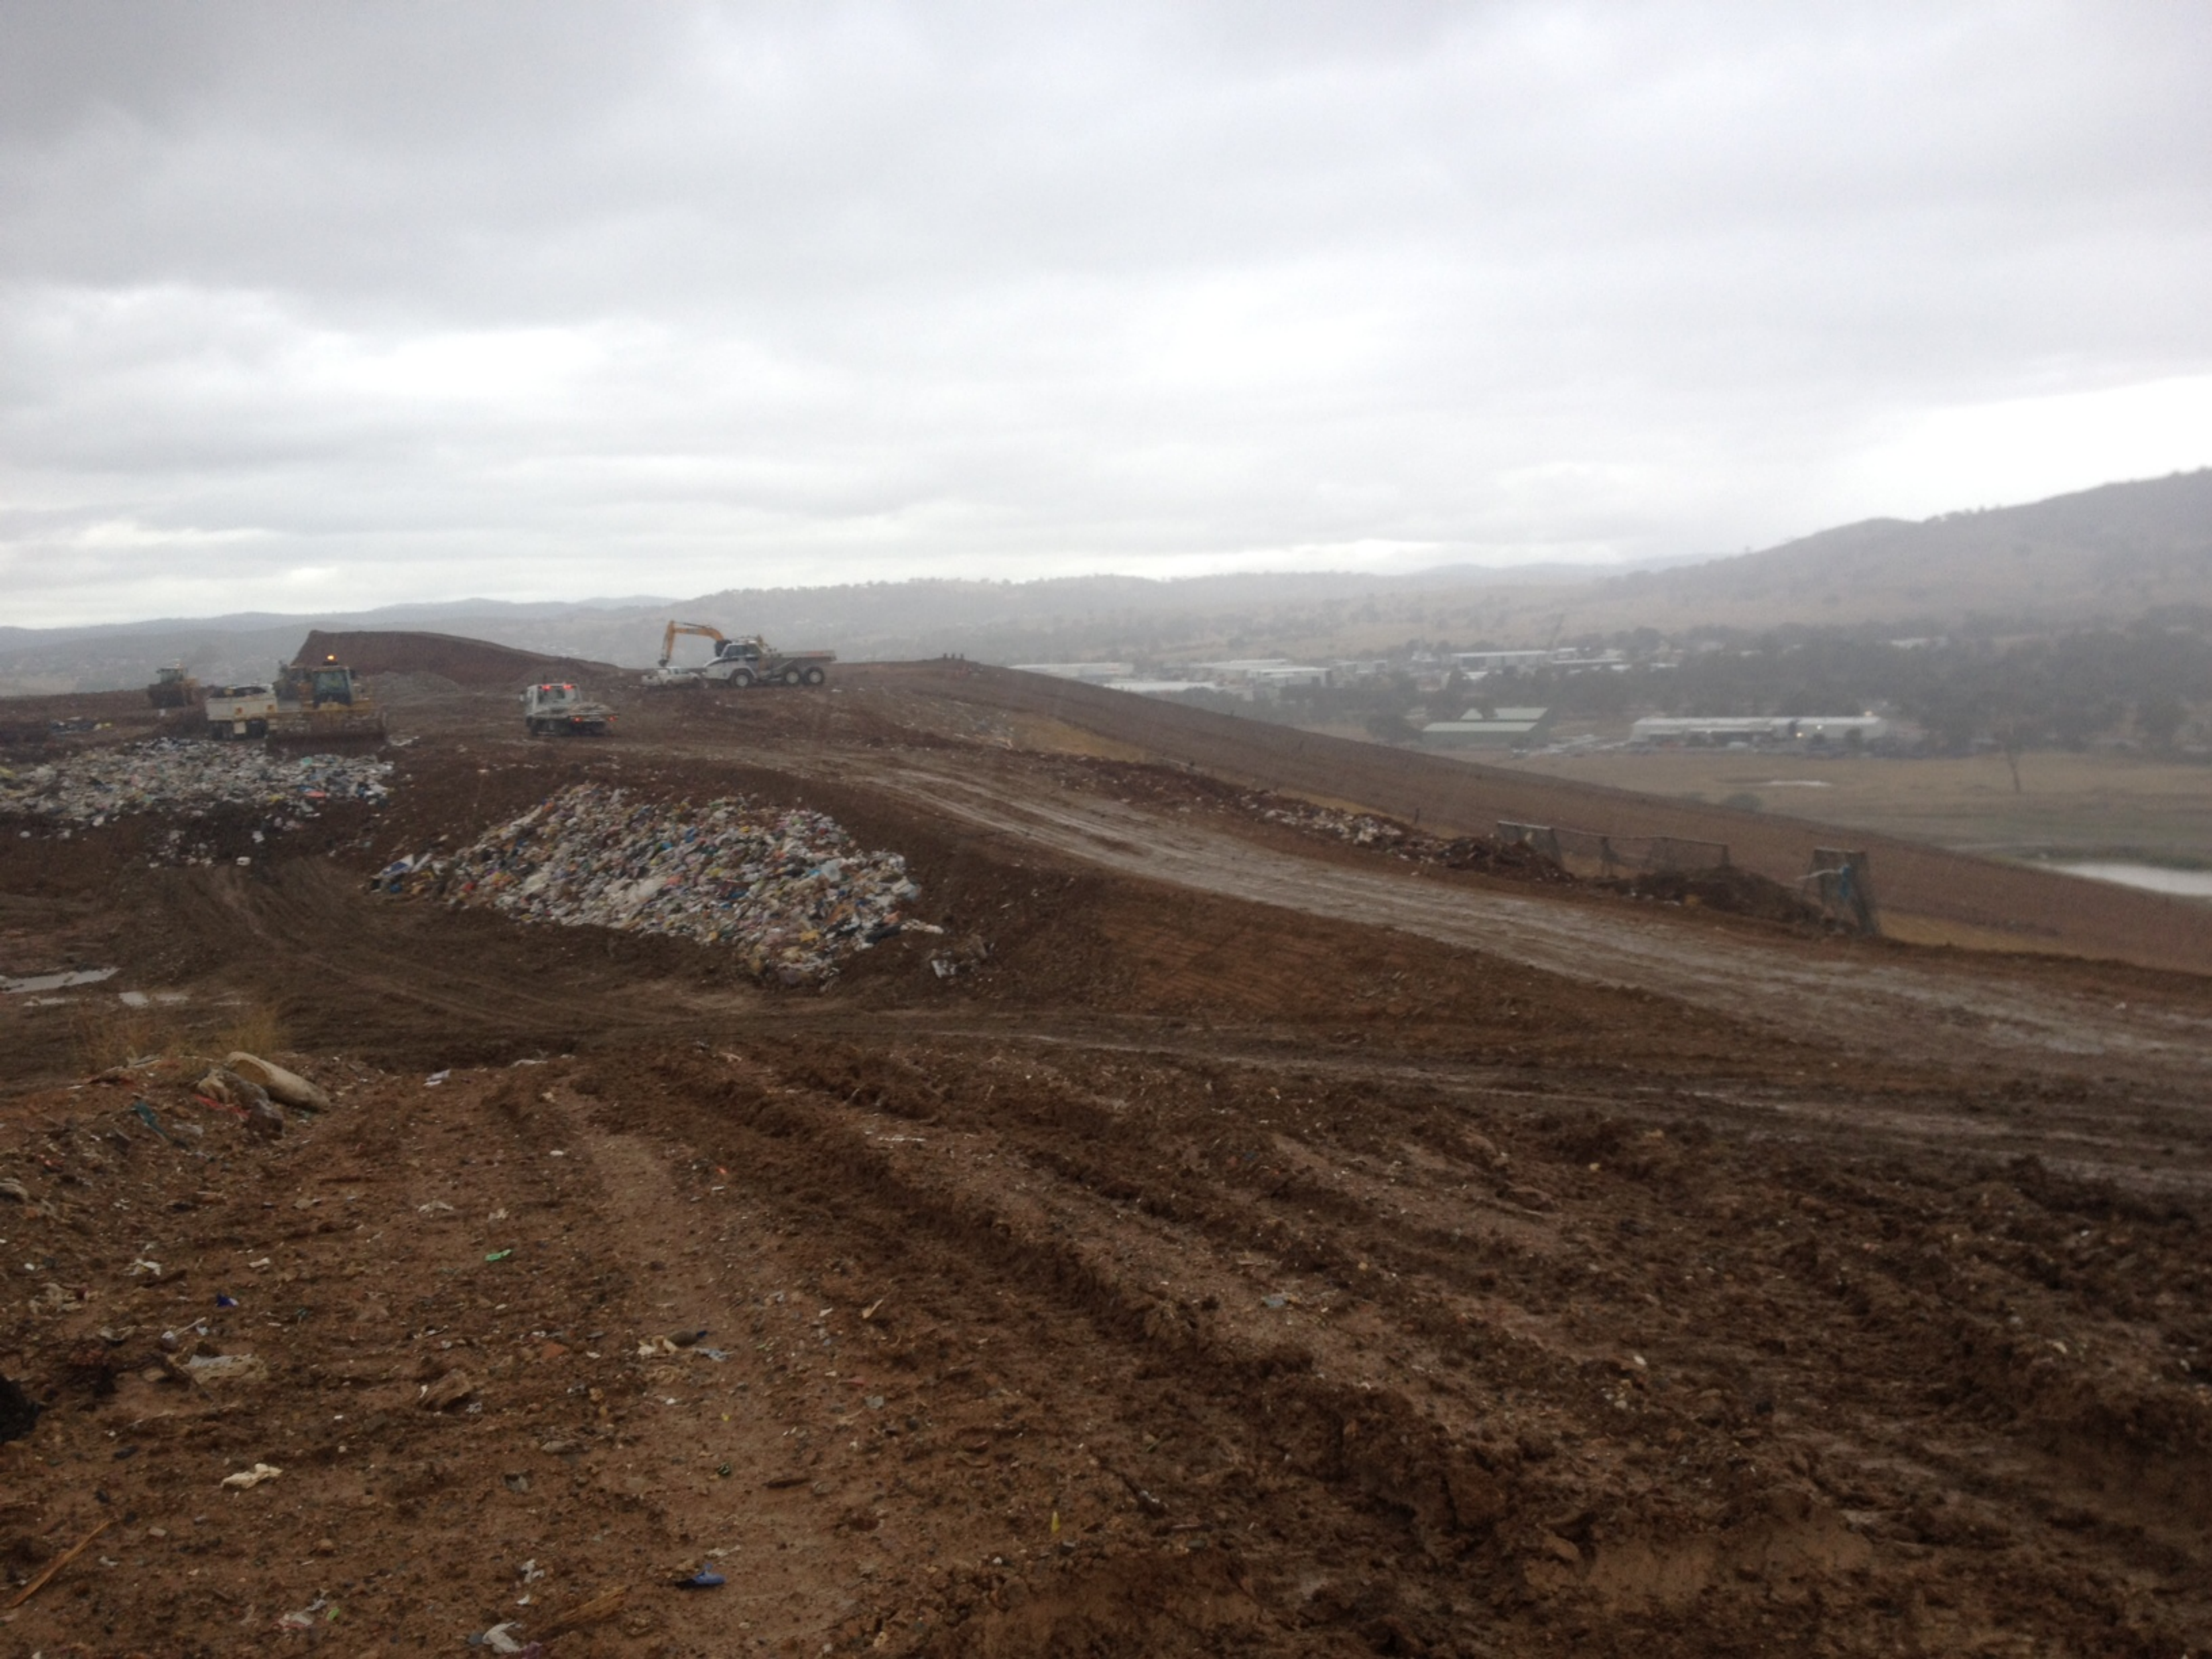
- a) Meteorological conditions at the site at the time; **light winds from n/e around 25 degrees**
- b) Time and date stamped photographs of the active tip face including photographs showing intermediate and daily cover; **attached**
- c) Details of any projects currently being undertaken by third parties that may impact on the generation of odour; **nil on site**
- d) Details of any measures taken or proposed to be taken to deal with odour generation; **Tipface no larger than 30x 30 meter and covered at the end of shift**
- e) The current level of the leachate dam. **25%**
