Environmental Investigation – Audit Report

**Yarralumla Brickworks
Sandford Street Complex
Block 1 Section 102 Yarralumla
Canberra Central ACT**

**Yarralumla Brickworks
Denman St.
Yarralumla
ACT 2600**

Title: Hazardous Materials Survey
Yarralumla Brickworks
Denman St.
Yarralumla, ACT 2600

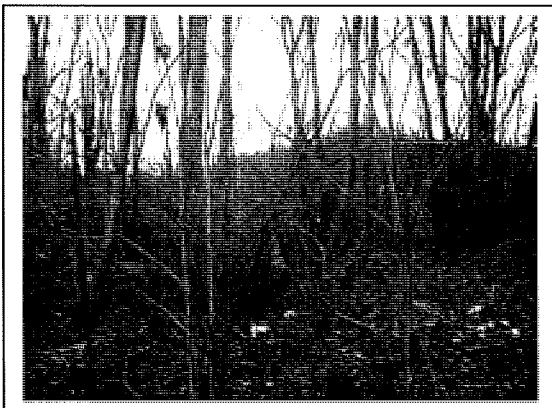
Photograph 3: General view of dump.
