Report on
Geotechnical Assessment – Urban Capability

Proposed Subdivision
Blocks 1605 – 1607, West Belconnen, ACT

Prepared for
The Riverview Group

Project 77356
February 2014

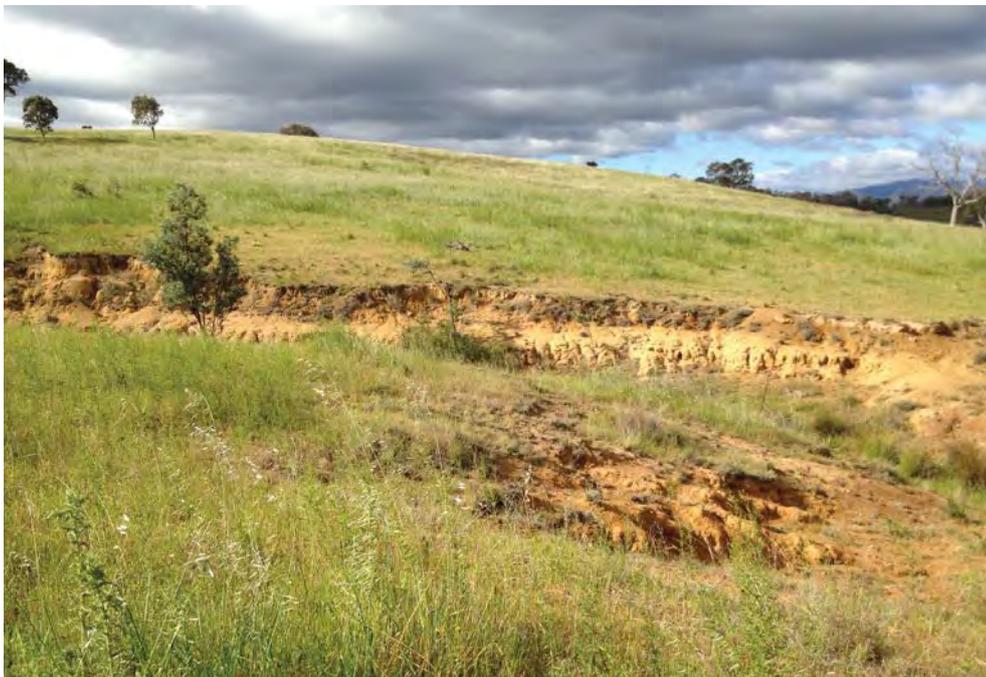
Photo A2 – Erosion in creek line. Refer Drawing 3 for locality and direction

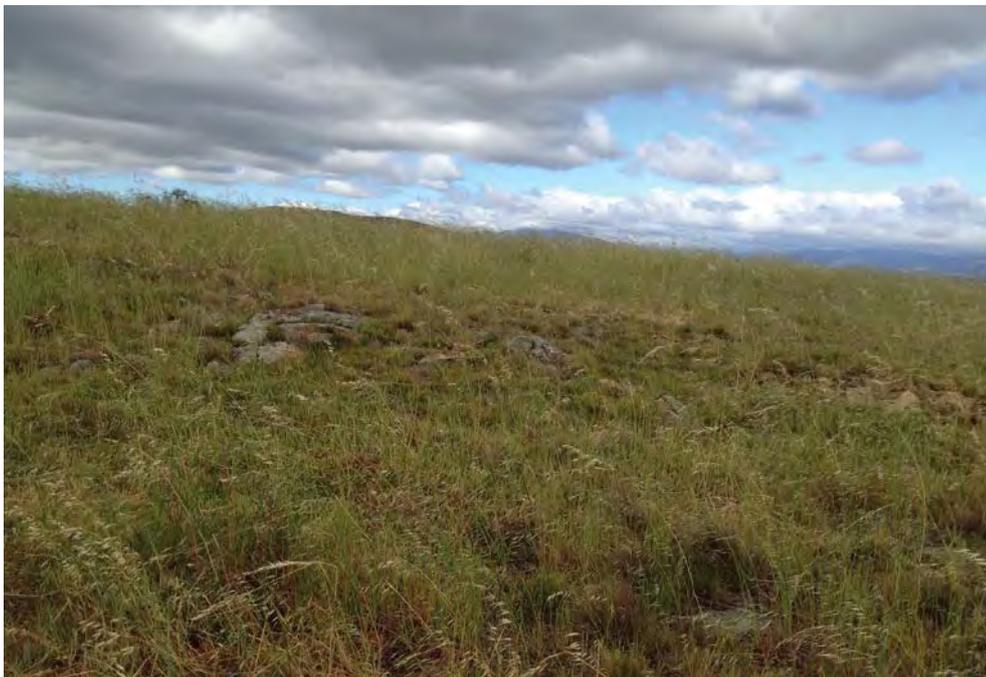
Photo A22 – Rock outcropping. Refer Drawing 3 for locality and direction

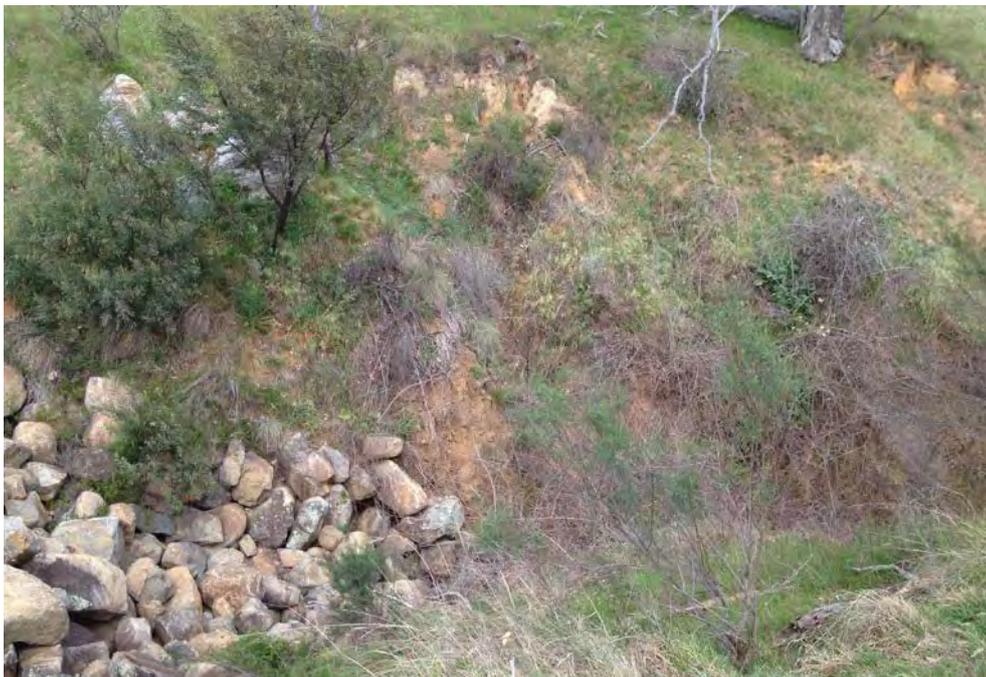
Photo A38– Placed cobbles and modification of creek line. Refer Drawing 4 for locality and direction

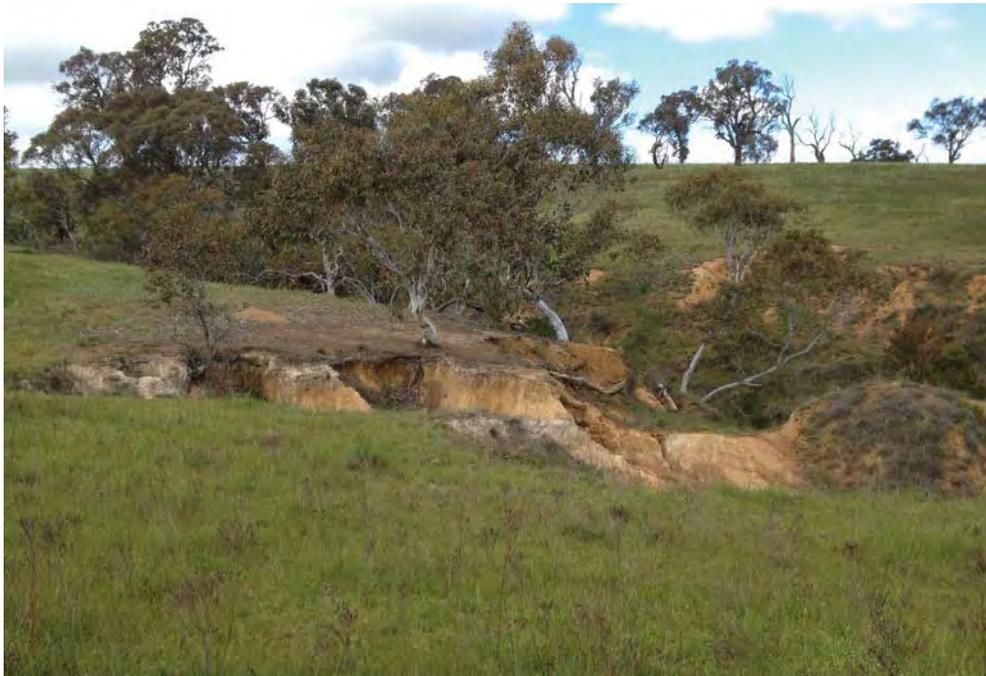
Photo A40– Erosion in gully line. Refer Drawing 4 for locality and direction

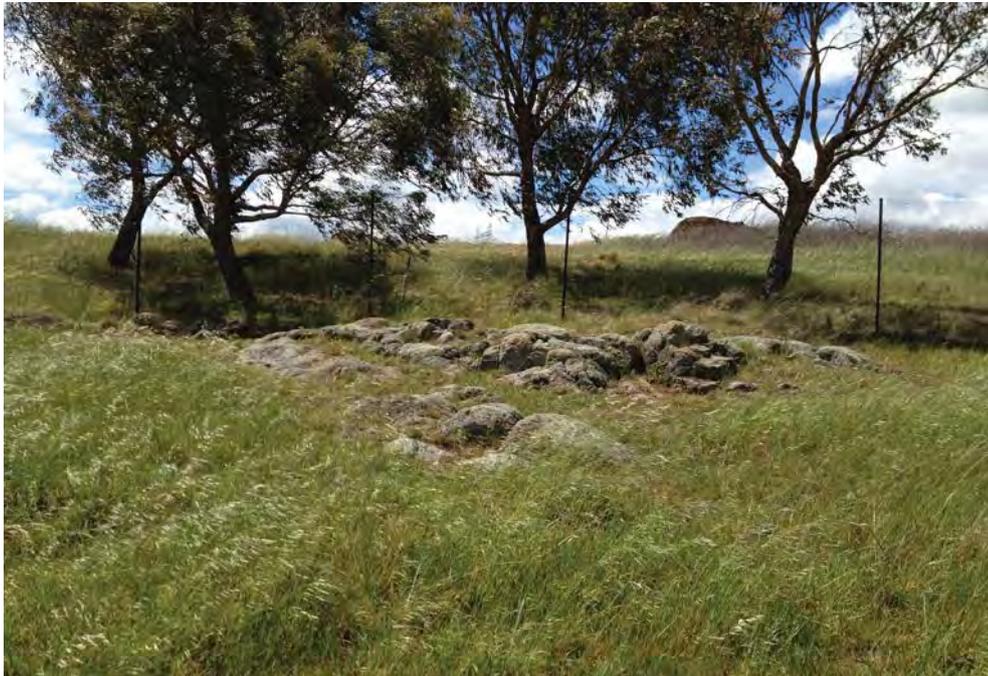
Photo A70– Rock outcropping. Refer Drawing 5 for locality and direction
