# Report on Geotechnical Assessment – Urban Capability Proposed Subdivision Lots 1 – 5 and 7 DP771051, Parkwood, NSW

This report presents the results of a geotechnical assessment for urban capability undertaken for the proposed subdivision located within Lots 1 – 5 and 7 DP771051, Parkwood, NSW. The work was requested by The Riverview Group, project managers for the development.

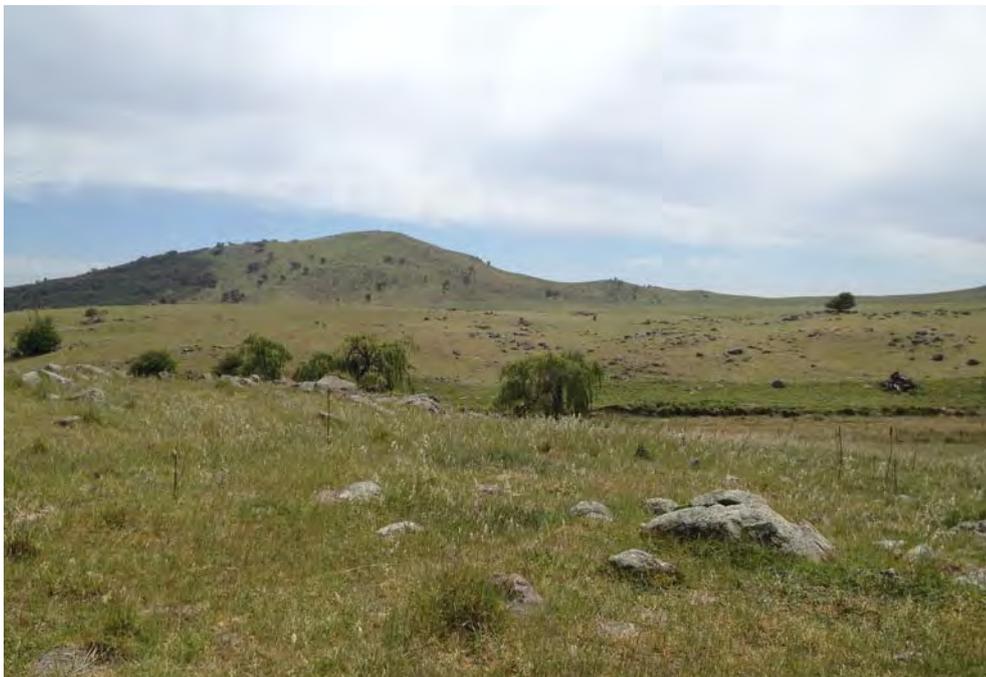
Photo N20 – Rock outcropping. Refer Drawing 3 for locality and direction

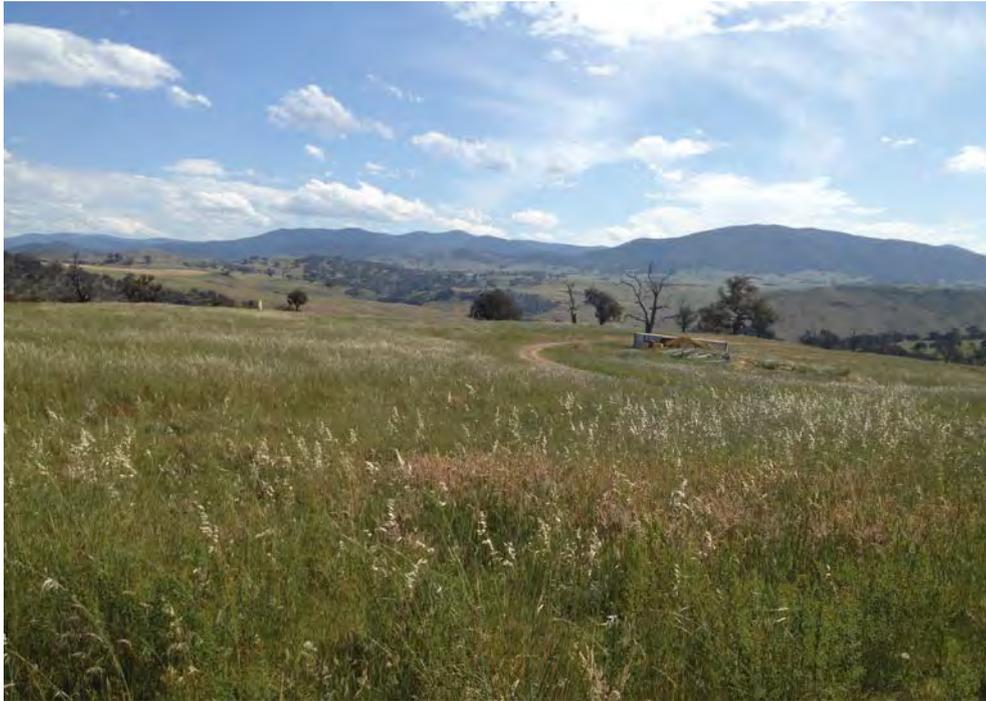
Photo N61 – Storage container. Refer Drawing 4 for locality and direction

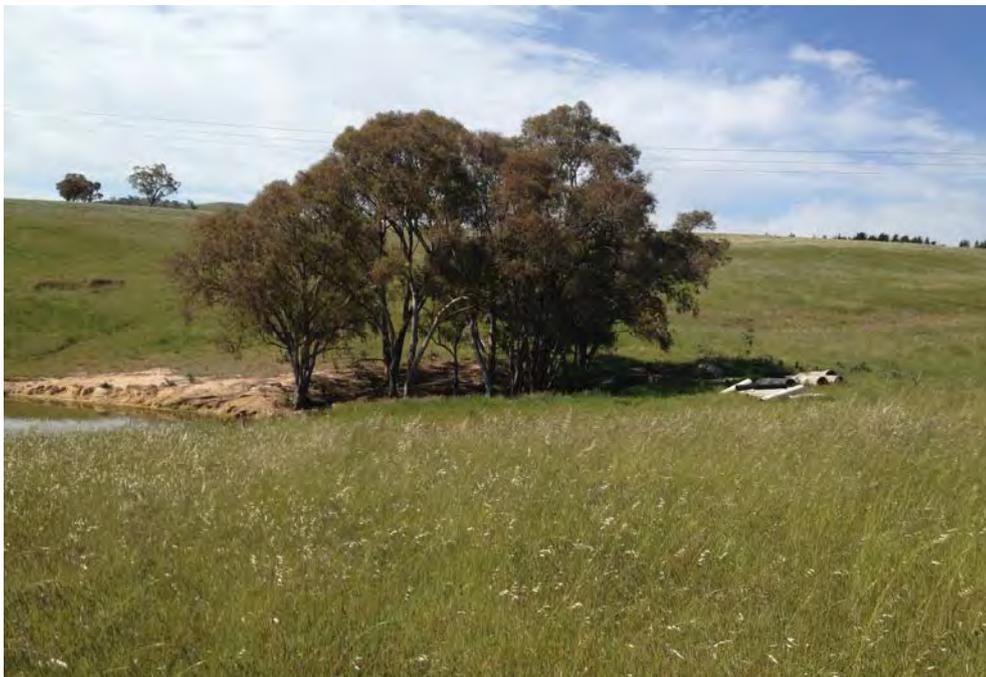
Photo N62 – Concrete pipes. Refer Drawing 4 for locality and direction

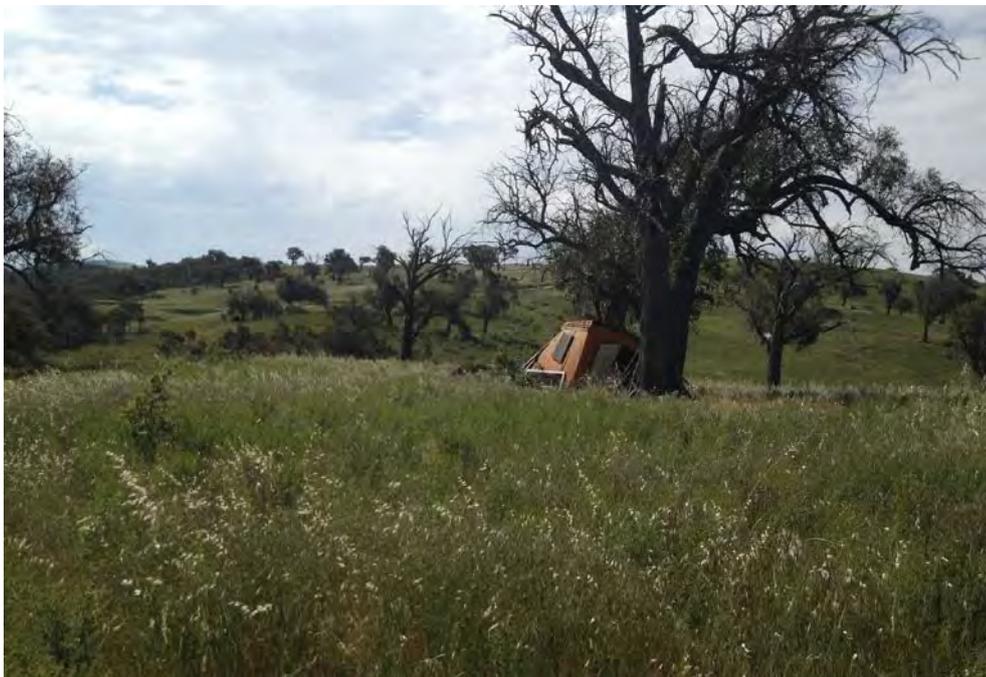
Photo N66 – Construction debris. Refer Drawing 4 for locality and direction

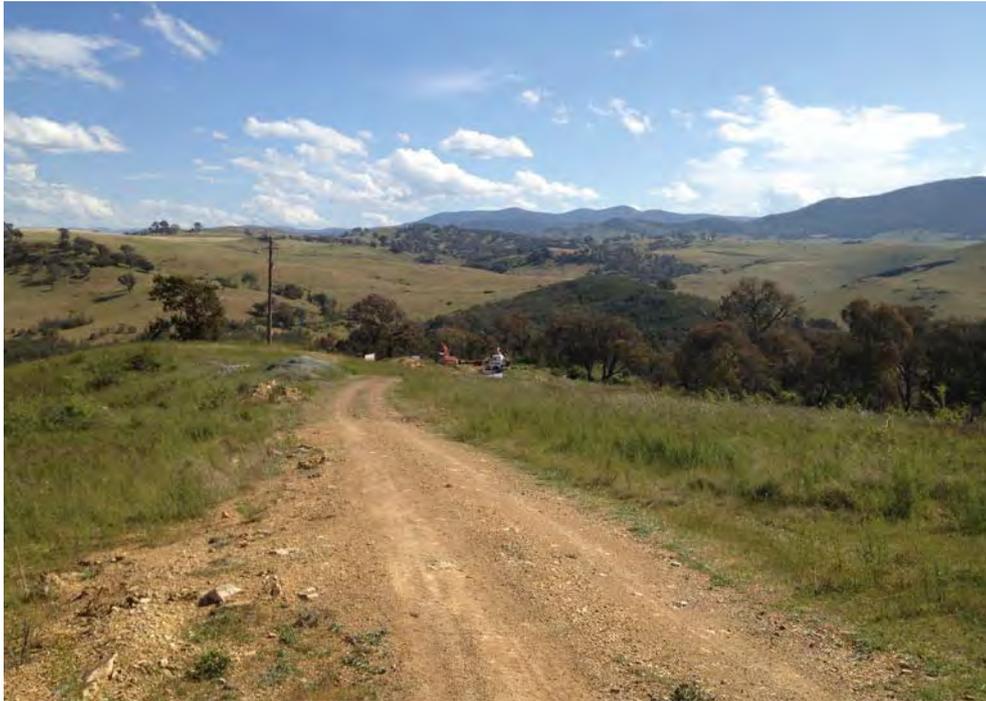
Photo N67 – Equipment storage. Refer Drawing 4 for locality and direction

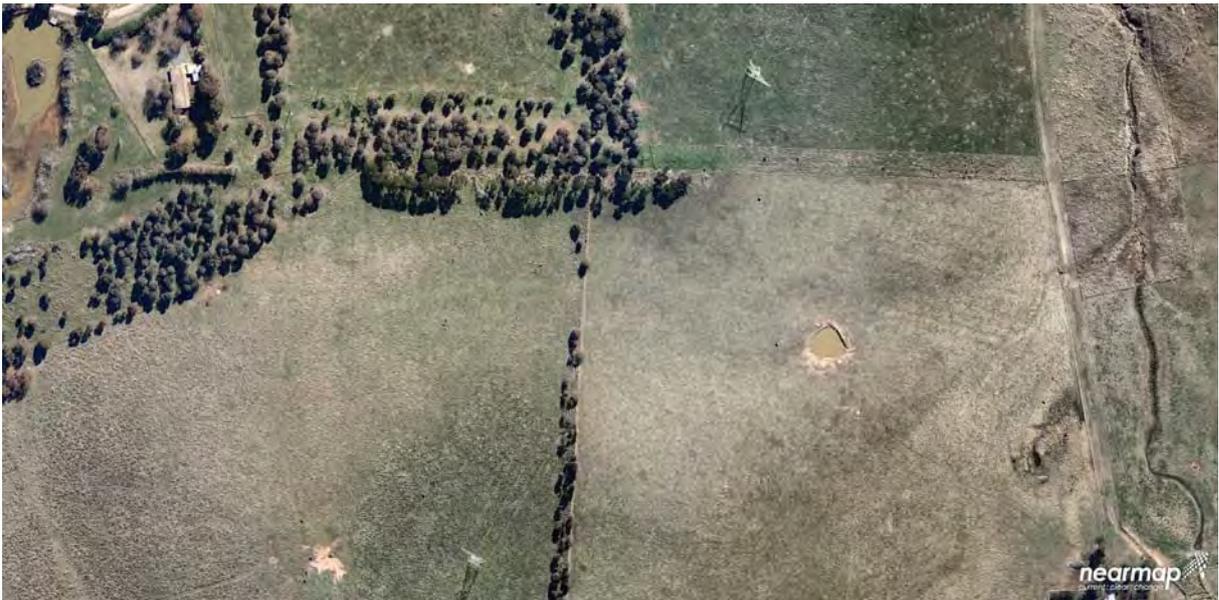
**Figure 2: July 2013 aerial photograph of Part of Block 1622. No Burnt ground evident.**

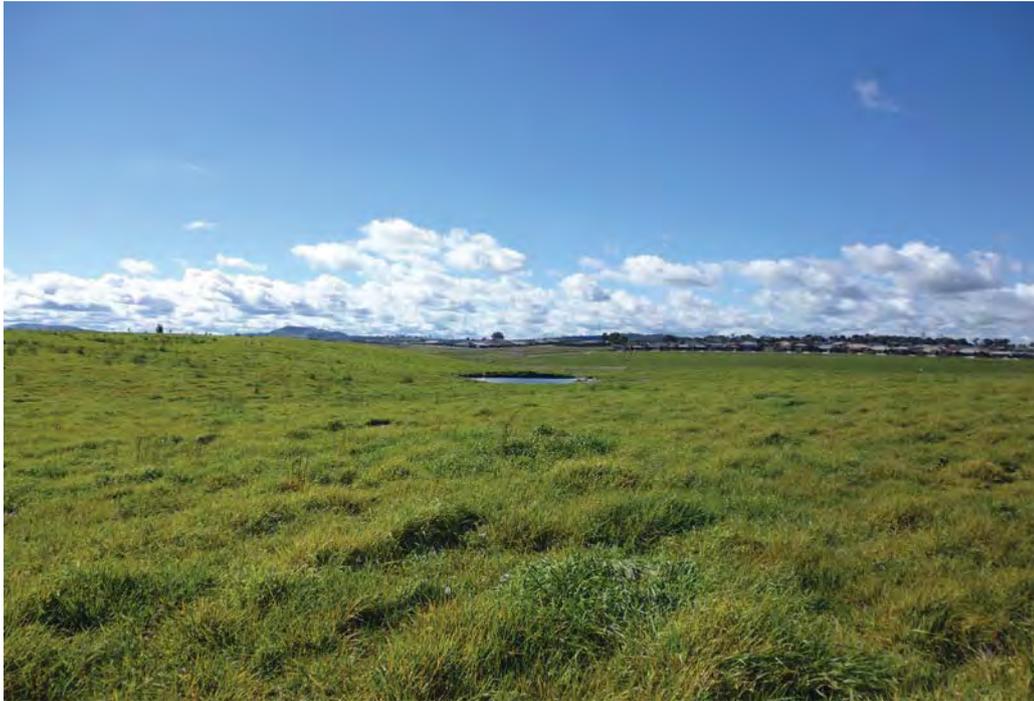
Photo A113 – View northeast at existing farm dam. Refer Drawing 3 for location.

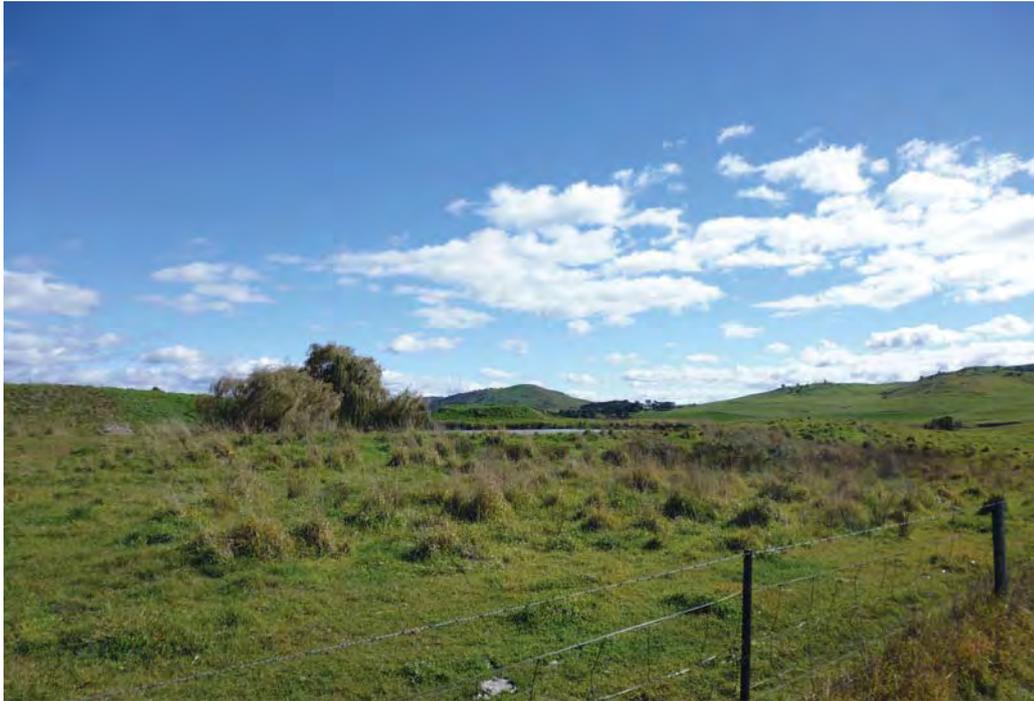
Photo A135 – View northwest at dam within Block 1329. Refer Drawing 3 for location.

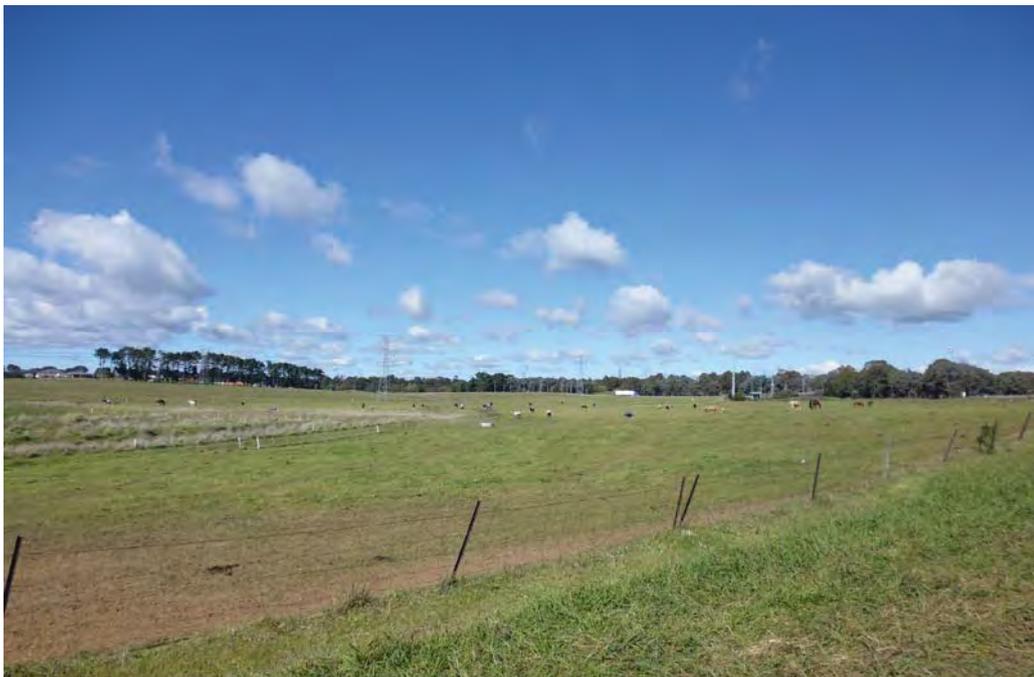
Photo A138 – View southeast at paddocks. Refer Drawing 4 for location.

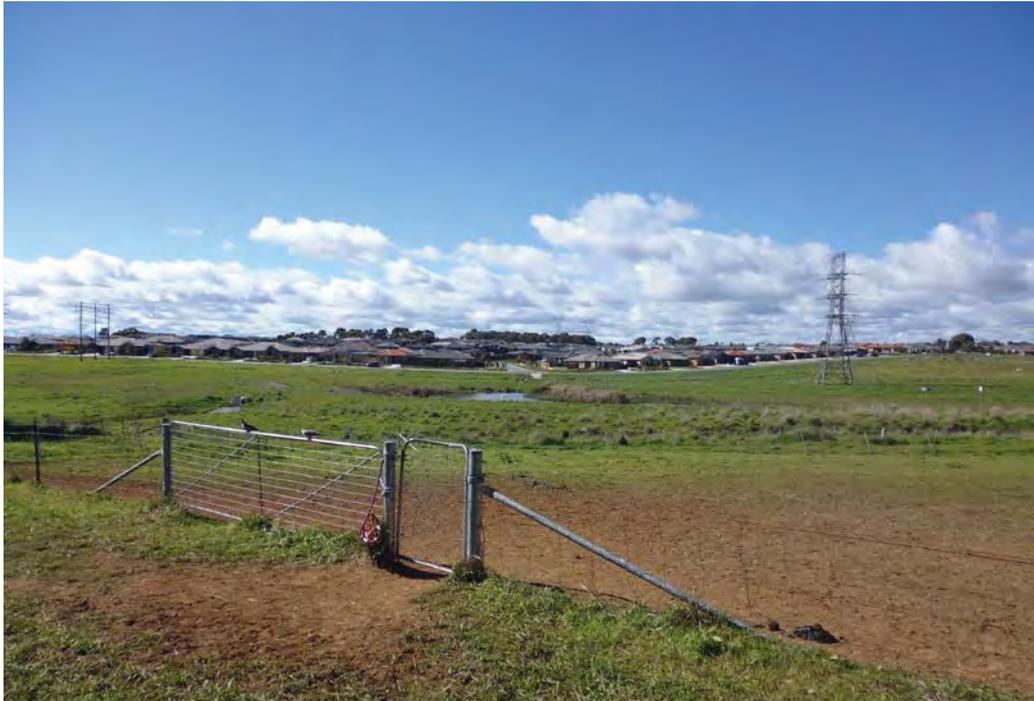
Photo A139 – View east/northeast at dams, paddocks and West Macgregor. Refer Drawing 4 for location.

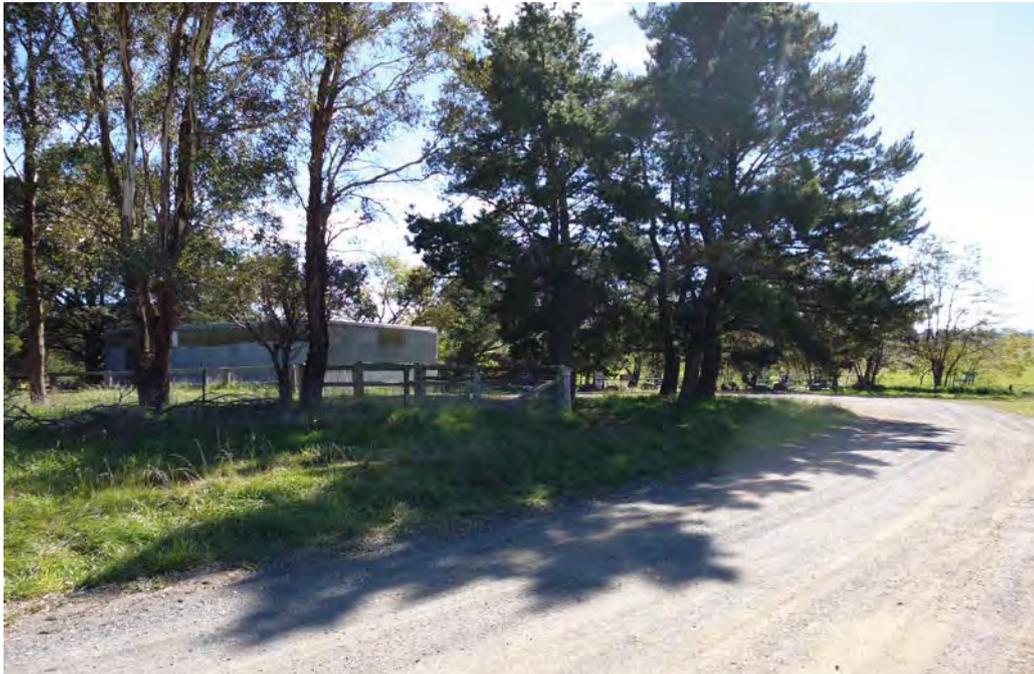
Photo A140 – View northwest at horse agistment sheds. Refer Drawing 4 for location.

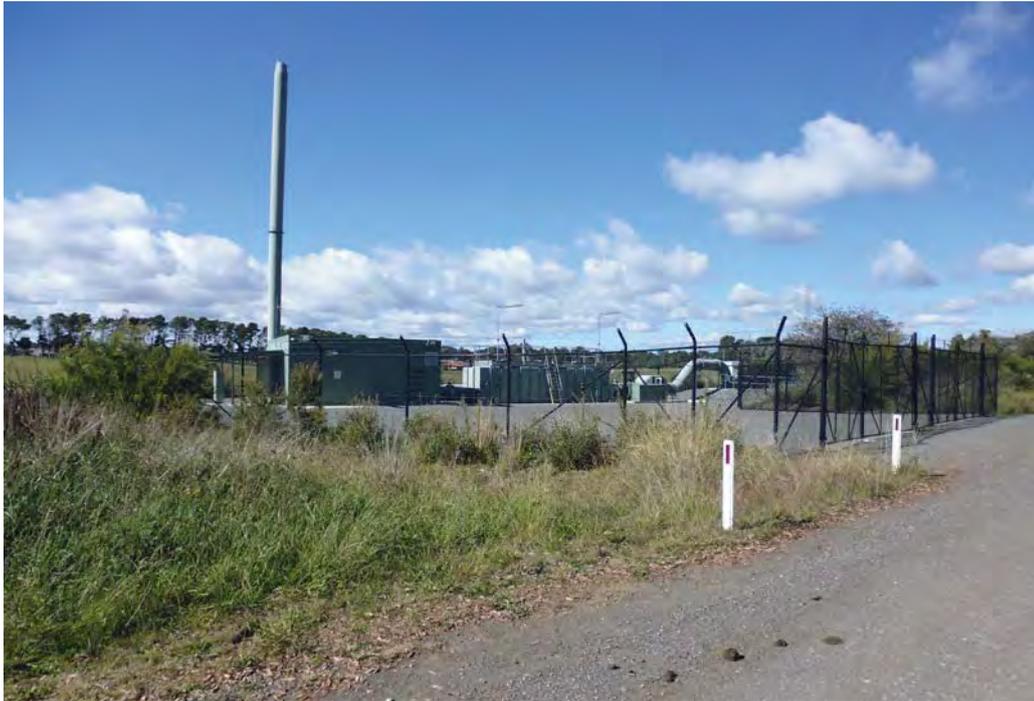
Photo A141 – View southeast at sewer pumping station/odour control plant. Refer Drawing 4 for location.

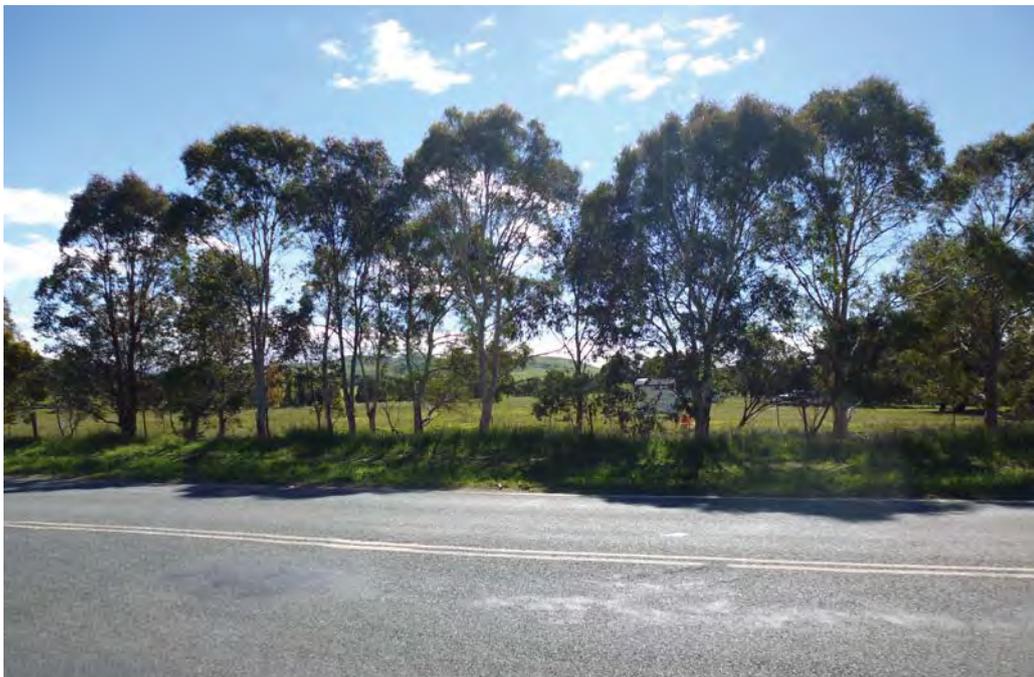
Photo A142 – View north/northwest at Block 1333 from Parkwood Rd. Refer Drawing 4 for location.

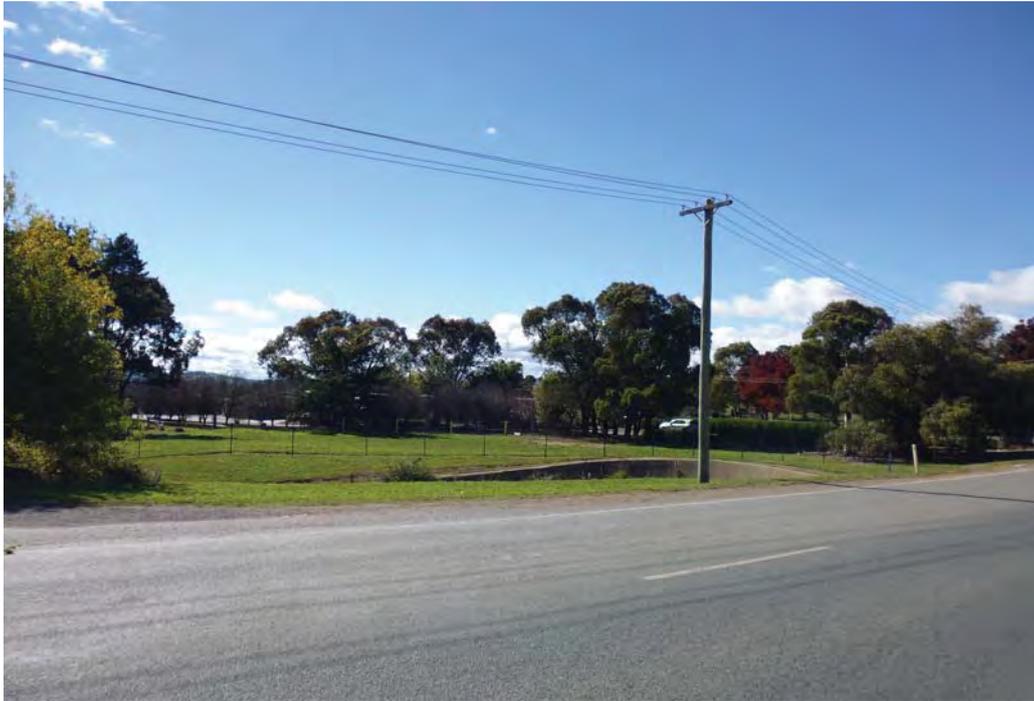
Photo A143 – View northeast from Parkwood Rd looking towards Block 858. Refer Drawing 4 for location.

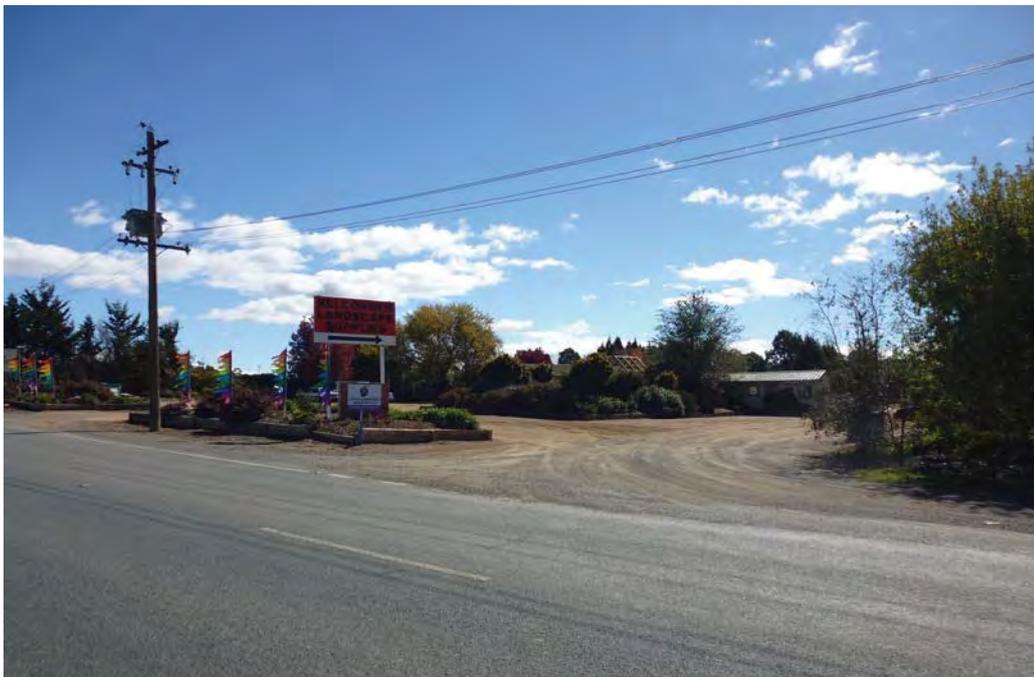
Photo A144 – View northwest from Parkwood Rd looking towards Block 856. Refer Drawing 4 for location.

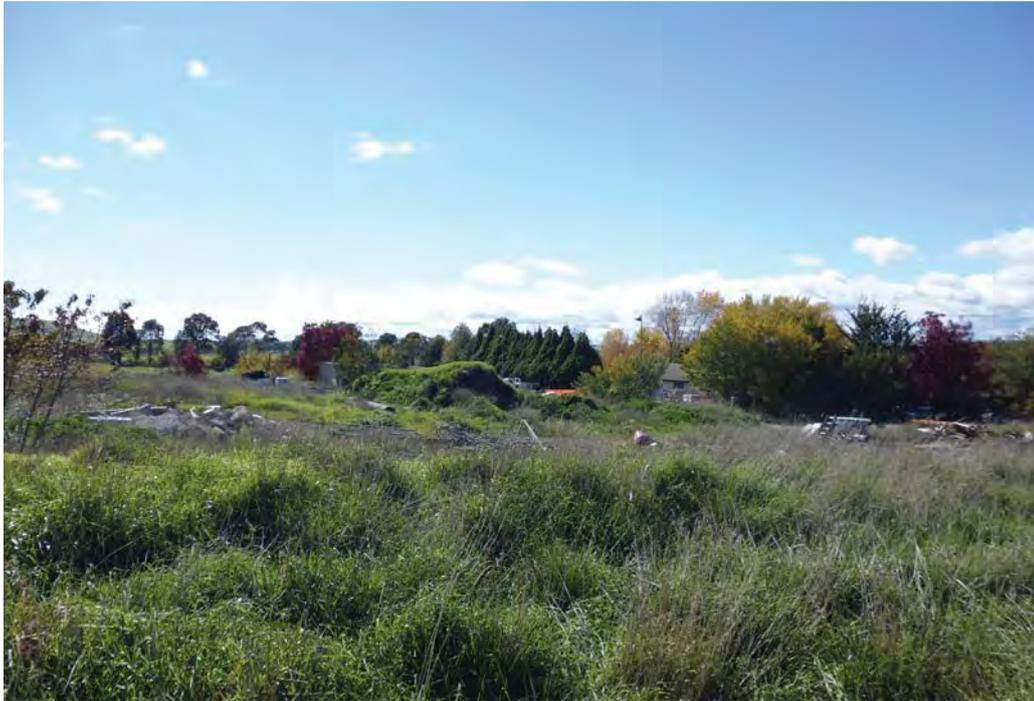
Photo A145 – View north from Parkwood Rd looking towards Block 1540. Refer Drawing 4 for location.

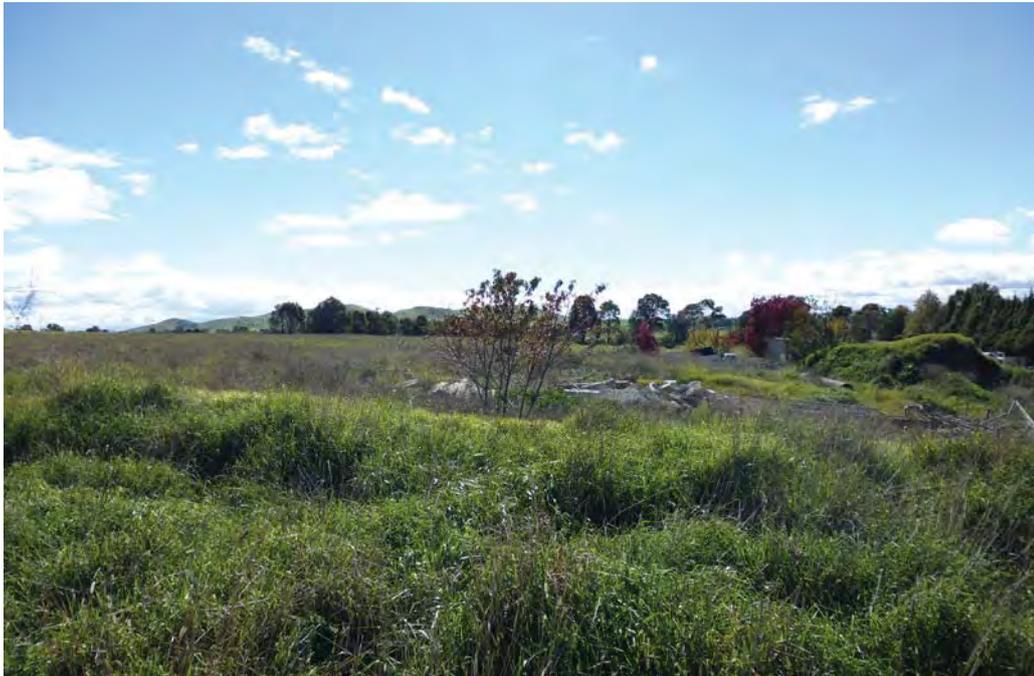
Photo A146 – View north from Parkwood Rd looking towards Blocks 853/1540. Refer Drawing 4 for location.
